Peculiarities of residential buildings deformation with connected block-sections collision as a result of uneven settlement on collapsible soils

^{1,2} Zaporizhzhia branch of State Enterprise «State Research Institute of Building Constructions»

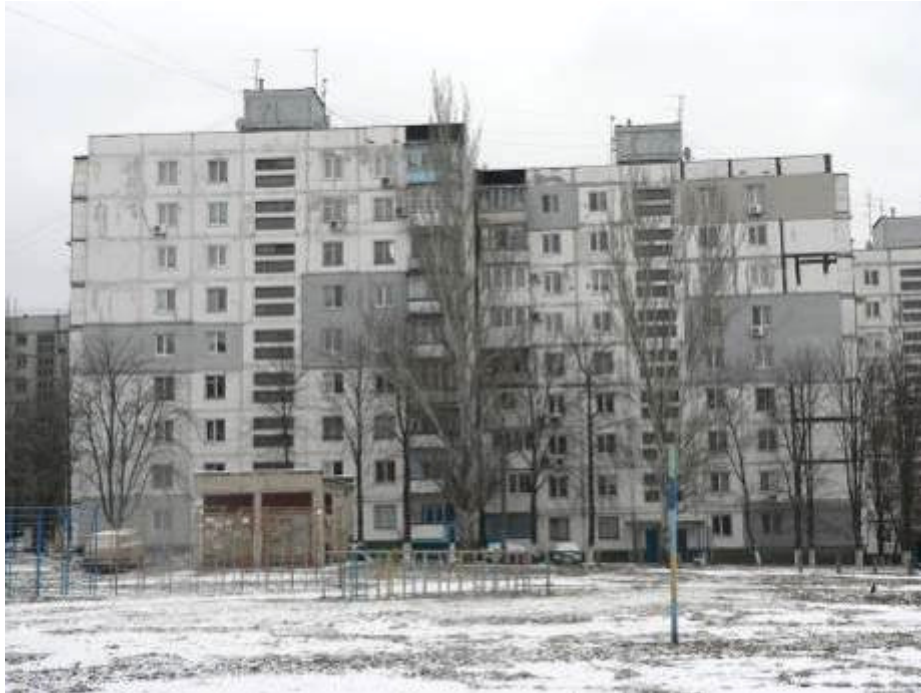
The main material and the results. Figures 2, 3 give a general view of a residential building and block-sections collision zone in a deformation joint with a 30% area of collision from the width of block section.

Figure 2 – General view of a residential building with collision of block-sections

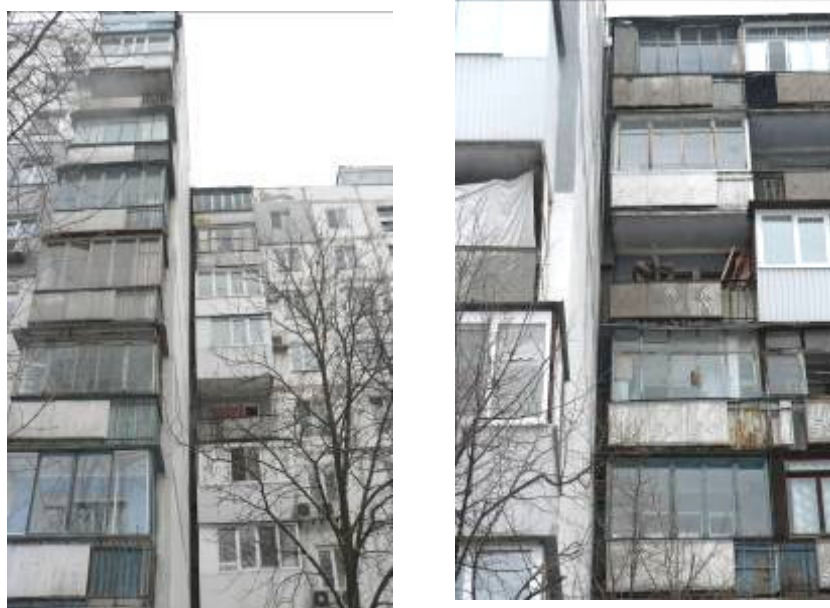
At the same time, the gap between the block-sections along the top of a deformation joint on this house was 250 mm under the project.

Figure 3 – The areas of house block-sections collision in a deformation joint

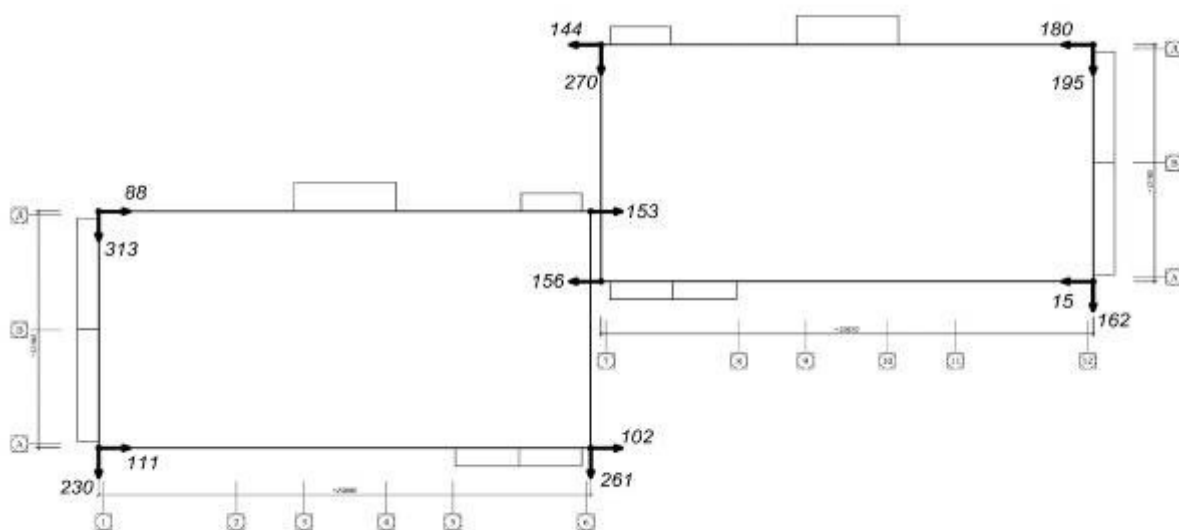
Figure 4 shows the indicative vectors of block-sections deviation from the vertical at the level of their top when they collide.

Figure 4 – Indicative vectors of deviation from vertical at the level of block-sections top when they collide

The unevenness of settlement on each block-section at the moment of measuring the block-sections deviation values was 225 – 250 mm. Depending on the values of uneven settlement and their distribution, in terms of each block-section, block-sections deviation magnitude is different. Depending on uneven settlement process course increasing in time, the values of the deviations vector stabilize in time in parallel with deposition stabilization and block-sections structures deformation in the area of their collision. Processes stabilization of block-sections deviation uneven settlement increasing from the vertical and the collision forces is achieved with the equilibrium between the values of uneven settlement, the efforts of block-sections collision and walls resistance. The values of structural elements deformation and damage are conditioned by the magnitude of block-sections collision force. With the values of block-sections deviations vectors (tilt) shown in Figure 4, deformations and damage of the panels and their joints in the area of block-sections collision are recorded. Along a deformation joint, complete «closure» of the gap between block-sections outer walls planes at the level of the ninth and eighth floors is formed. Panels joints opening is up to 6 mm. The cracking in the wall panels reaches 6 – 8 mm. The zones of panels damage by grid of cracks are also fixed with the fragmentation of panel concrete by the efforts of plane pressure with the areas up to 1 – 3 m². Slabs of the overlap formracks with opening up to 0,3-0,5 mm. According to the criteria [2], structures technical state in the zone of block-sections collision in general has reached the «3» category – unsuitable for normal exploitation. According to the criteria [2], structures technical state in block-sections collision zone in general has reached the «3d» category - unsuitable for normal exploitation.
