Peculiarities of structures inspection by the example of a three-chamber navigation lock in Zaporizhzhia city

Peculiarities of structures of hydro technical structures technical condition are considered. The problem concerning normative documentation on the inspection of hydraulic structures is considered, and the absence of standards for the inspection of this type structures is revealed. The issue of hydraulic structures inspection by the example of a three-chamber lockin Zaporizhzhia city is considered. The issue of the deformed state according to observations of past years are considered. The recommendations for the further exploitation, repair and completion of reconstruction of a three-chamber lockin Zaporizhzhia are given.

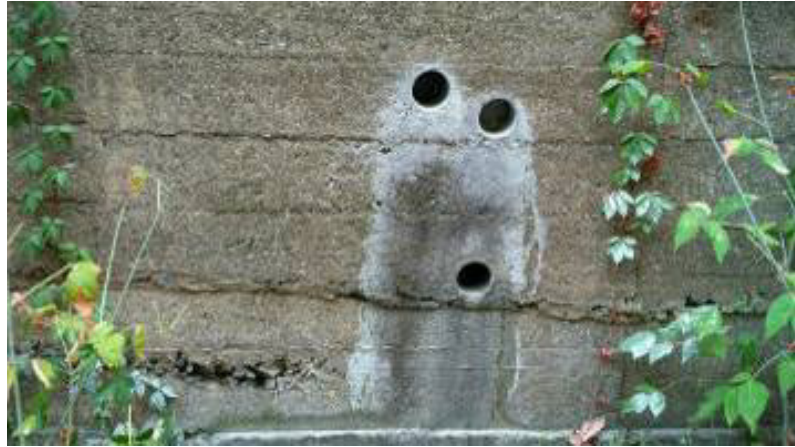
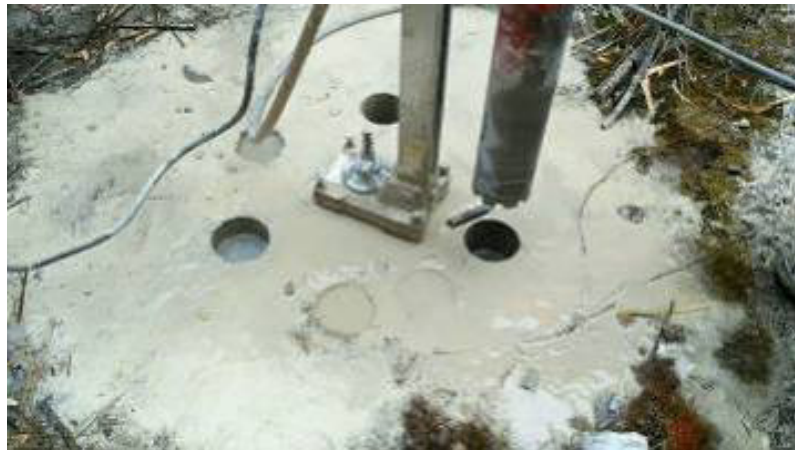
Figure 3 – General view of construction site with sampling area

- wall of the 1st lock chamber – 4 batches of 3 samples $\varnothing 94$ mm (designation K1.1–K1.4);
- the bottom of the 2nd chamber of the lock – 2 batches of 3 samples $\varnothing 94$ mm (designation K2.1–K2.2);
- the walls of the 3rd head of the lock – 2 batches of 3 samples $\varnothing 94$ mm (designation Г3.1–Г3.2).

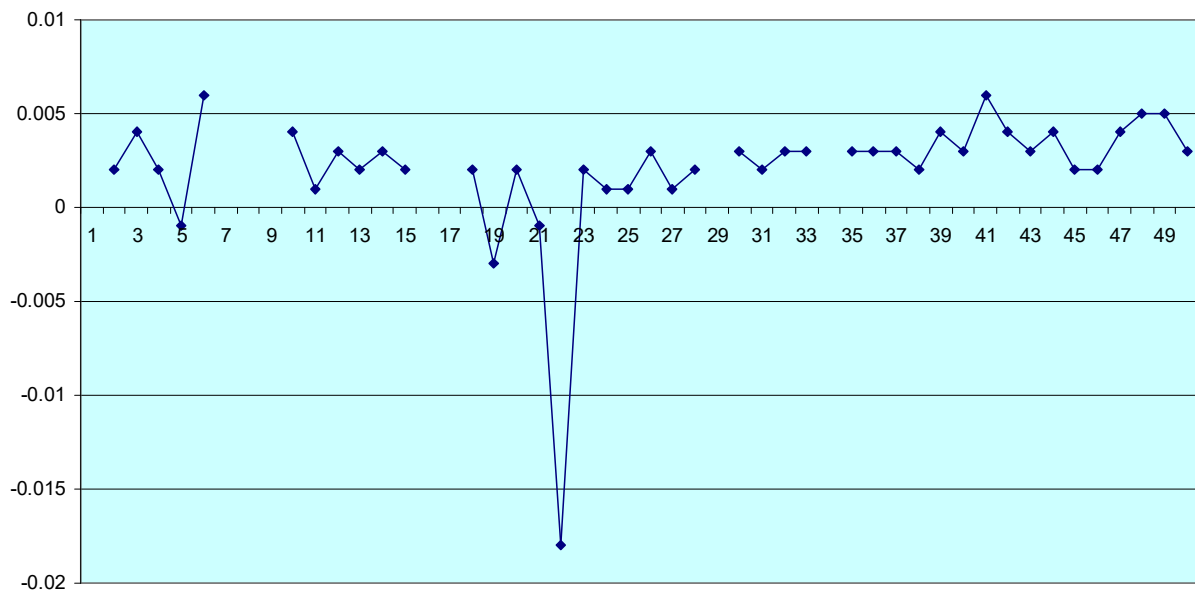
Figure 4 – Graph of deformation control benchmark change of three-chamber lock during the period from 1975 to 1985 (on the graph 1 ... 50 – mark numbers 0.01 ... 0.02 – change of marks in [m], breaks of the chart in the places of marks destruction)

- the leveling data given by customer do not reflect inspected object deformed state;
- unidirectional deformations of adjacent sections during the observation period have not been recorded;

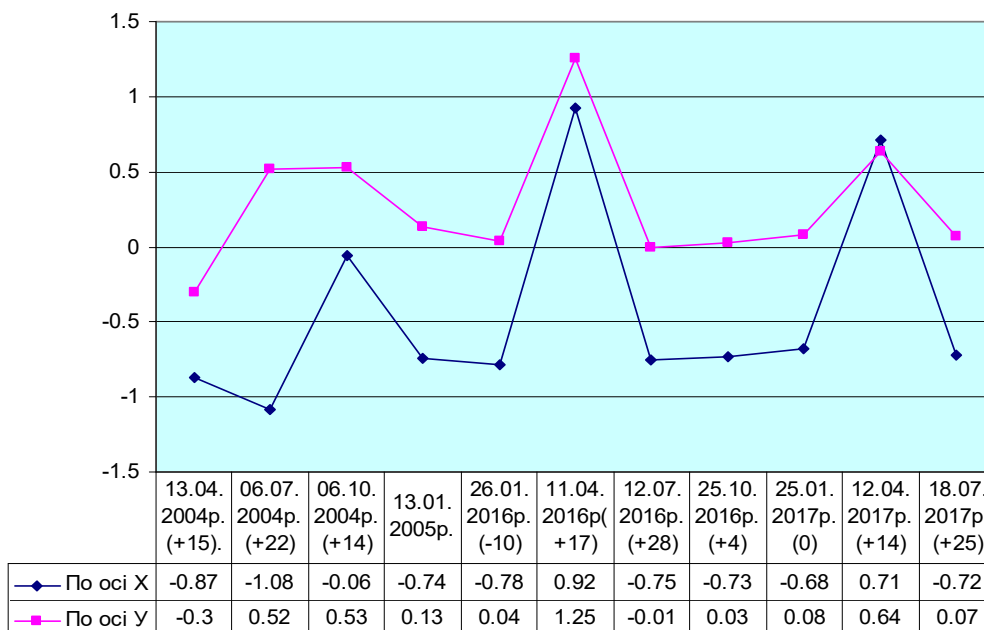
**Figure 5 – Deformation graph along the joint 2-04
(on the graph: 1.5 ... -3 – step value in [mm];
13.04.2004 – date of data readout; +28 ... 10 – outdoor air temperature)**

the revealed increase of the measured values basically indicates concrete anays temperature deformation;

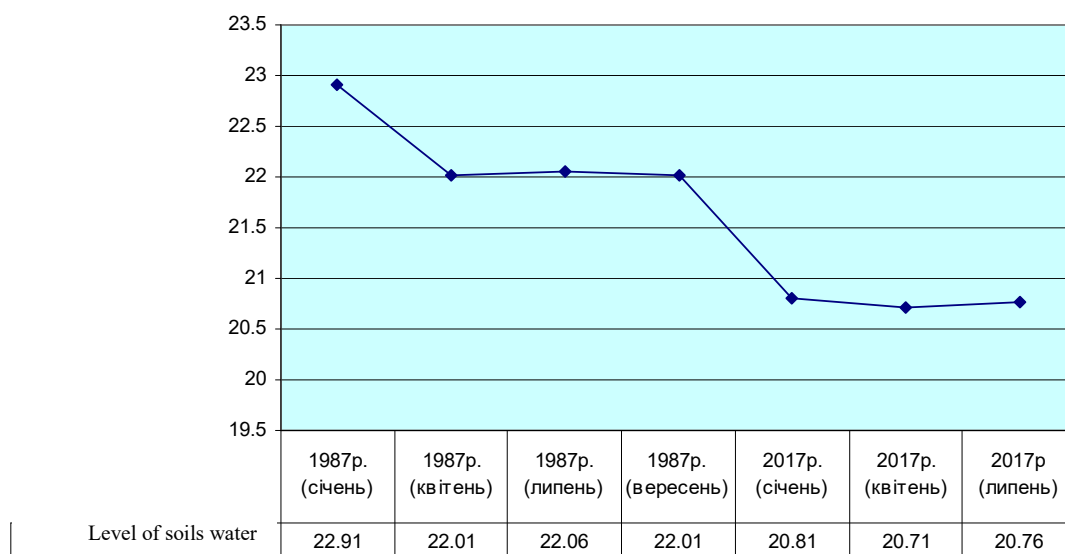
**Figure 6 – Graph of groundwater level change by piezometers TR-3
(on the graph: 23.5 ... 19.5 – water level mark in [m];
1987 ... 2017 – date of data readout)**

- for the period from 1987 – 2017 ground water level has decreased, which is due to the stopping of three-chamber lock exploitation and new depression curve formation.
