RESIDENTIAL BUILDING'S DEFORMATION ON PILE FOUNDATION

Vynnykov Yuriy^{1*}, Manzhaliy Sergiy²

A considerably distinctive deformed five-storeyed three-section brick residential house erected over 40 years ago on driven prismatic piles combined by a strip grid foundation by a standardized project is under investigation. The geotechnical monitoring results of the building's technical condition are presented. Methods and results of the instrumental control analysis of the piles' actual length and visual evaluation of their integrity are presented. The causes of the foundations base's excess deformation were determined: the inability of the piles' tips to reach the designed mark; the piles' destruction during their immersion in dense sands; rupture of the primary thermal network, which led to "negative friction" effect on the piles' lateral surface, etc.

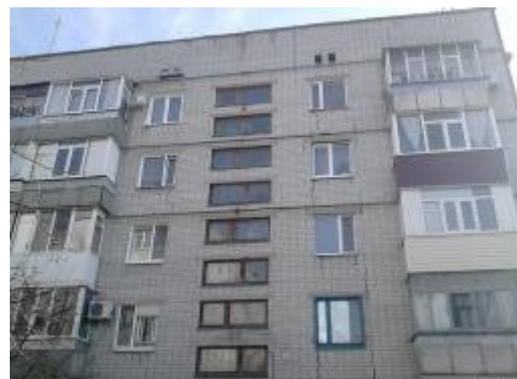
Figure 1 – Fragment of the left block section on the axis B

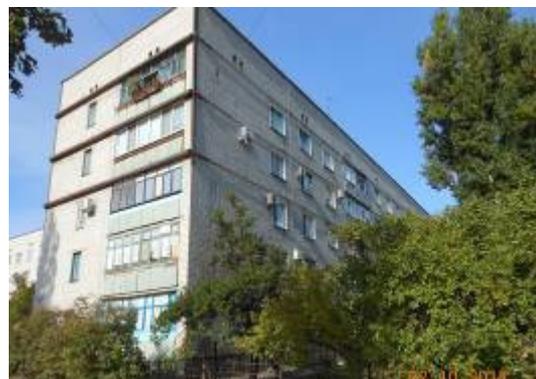
Figure 2 – View of the left side block section in the axes A-B and on the axis A

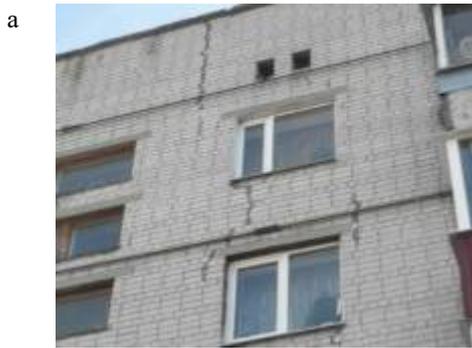
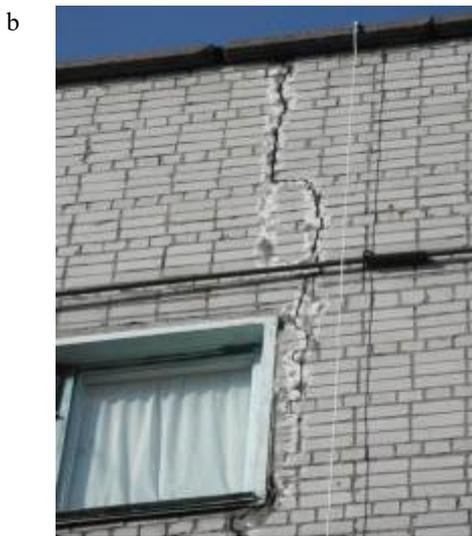
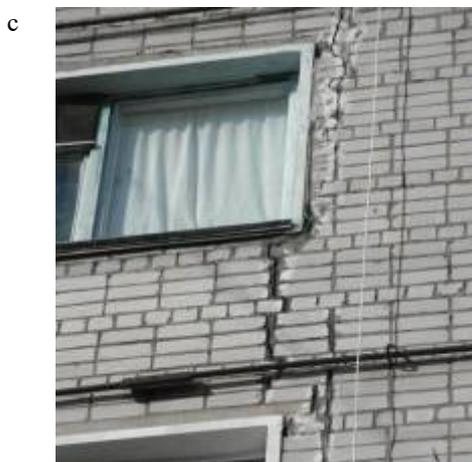
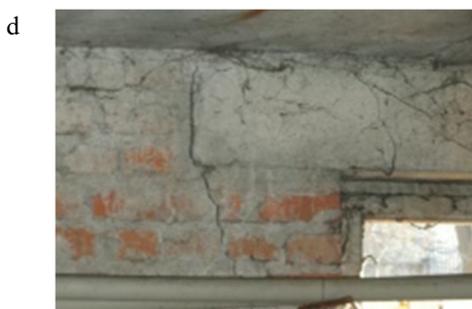
Thus, vertical cracks (Fig. 3) were detected at the entire height in the outer load-bearing walls, mainly at the places of the spandrel beam supporting and over (under) the openings.

Cracks are typical for buildings with reinforced concrete spandrel beams that cause deformation of the window unit by turning it as a single rigid element. Cracks indicate significant deformation of the foundations' base of the left end section in the direction of separation from the main part of the building. The cracks propagation significantly reduces the spatial rigidity of the section because, for separated parts of the outer and inner walls, the spatial rigidity is no longer provided by the transverse walls of the stairwell. There are no cracks on the outer and inner walls of the staircase, which confirms the previous statements.

Figure 3 – Vertical cracks with opening width:
a – 7 mm; b – 15 mm; c – 12 mm; d – 4 mm

Therefore, the technical condition of the outer and inner bearing walls is classified as unsatisfactory.

- strengthen the outer and inner bearing longitudinal walls to prevent the reduction of its spatial rigidity by dividing them into separate blocks (columns) by cracks. For this purpose it is possible to use already existing inefficient metal structures of reinforcement or to execute reinforcement with outer metal linings from rolling profiles;

- to chipper and rip cracks open with M 100 cement sand mixture (alternatively, injection of these cracks with M 100 solution);
 - eliminate depressurization of the main thermal pipeline at the exit from the right end block section in axes III-IV;

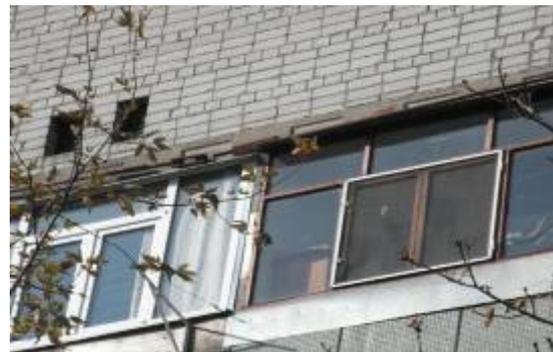
Figure 4 – Break of the upper tension bar along axis A at the level of the fifth floor overlap

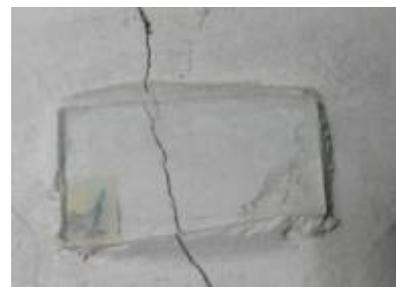
Figure 5 – Crack in the tell-tale (fifth floor)

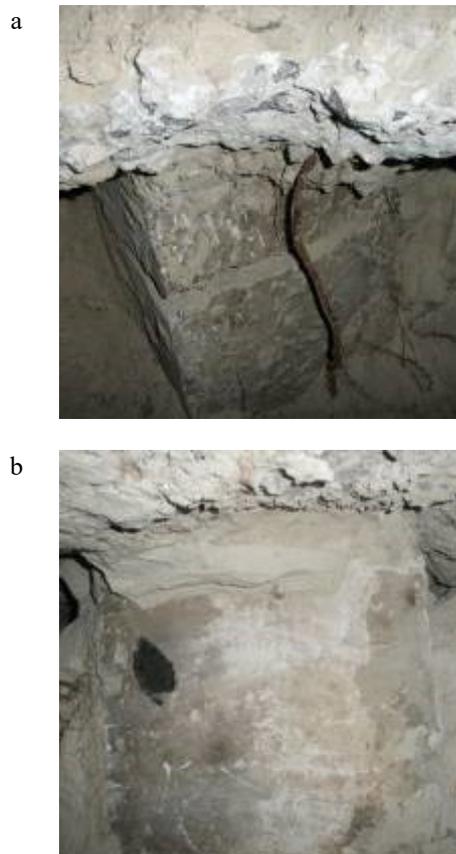
6 exploratory shafts were made for these tests, and the pile body was cleared by 20 cm, 3 of them located in the damaged left block section (axis I – II), 2 – in the row block section (axis II – III) and 1 – in the right block sections (axis III – IV in Fig. 6). The pile length control process is shown in Figure 7.

Figure 6 – The piles view as a part of the grid: a – №1 (pile №119); b – №2 (pile №105)

Shaft / pile №	Actual pile length, m	Notes
1/119*	Pile destroyed	The pile damage due to deviation from the design position while driving. The pile operates on eccentric compression due to the considerable eccentricity of loading and pile's body deflection from vertical. The crack opening in the pile - 40 mm.
2/105*	8.5	–
3/9*	4.5	–
4/77	8.5	–
5/171	6.0	–
6/33	7.5	–

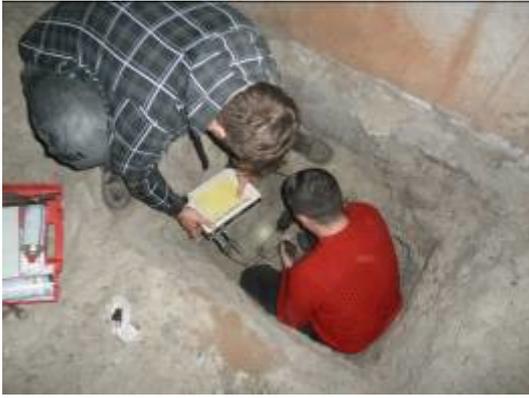
Figure 7 – Performing pile length control work

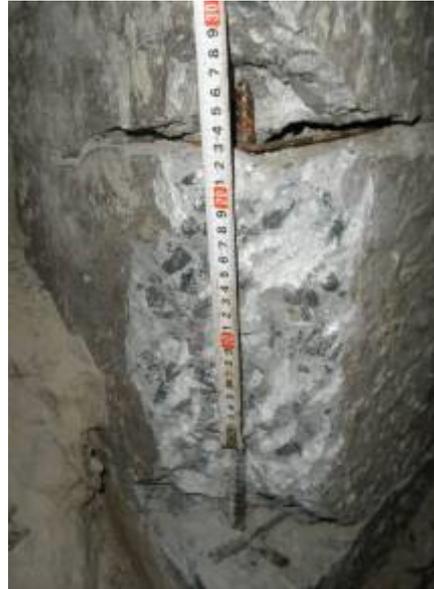
Compared to the nondestructive testing stage, during the investigation of the pile's reinforcement, the exploration shaft was deepened, revealing cracks in the pile body (Fig. 8). The pile was destroyed since the protective layer of concrete was split in a stretched zone. The concrete in the compressed area split and crumbled. The increment of the transverse reinforcement was 200 mm. It shows that the pile was not driven to the designed mark, it was “cut down”. The minimum length of the “cut” part was 600 mm. In this state, the pile does not withstand vertical compressive loads. The results of the instrumental control analysis of the pile's length and visual assessment of their integrity are summarized in Table 1.

The pile reinforcement check confirms the assumption that part of the pile failed to be driven to the design mark. The piles' lengths discovered in the instrumental survey are true. To establish the possible difference in settlement, a test calculation was performed for pile # 119 (shaft # 1) of a 4.5 m length with a cross-section of 350x350 mm. A vertical tie of this pile to the geotechnical column is shown in Fig. 9.

Figure 8 – The piles' view as grid component in pile reinforcement investigation:

a – pile №119 in shaft №1;

- strengthen reinforced concrete spandrel beam in the inner bearing wall of the basement in axes I-II on axis B;
 - restore the protective layer of concrete piles in which their reinforcement was investigated;

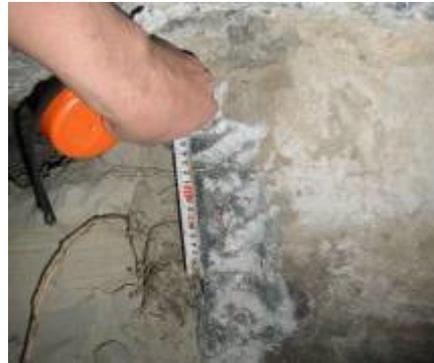
b – pile №105 in shaft №2 (the reinforcement increment in the survey was 100 mm, therefore, the pile's tip reached the design mark)

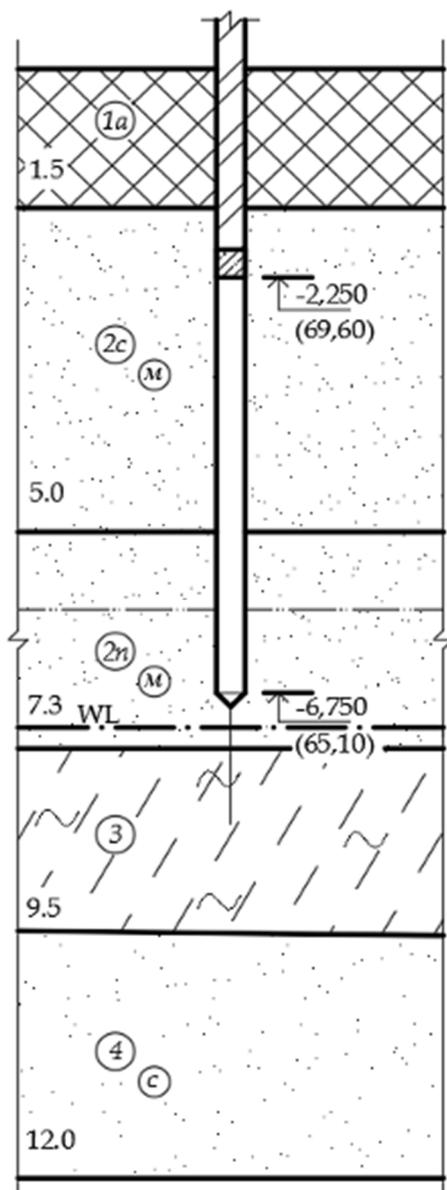
The following results were obtained in the calculation. Settlement of the pile is $S = 2.2 - 2.5$ cm based on the calculation method. Thus, the difference between the settlement of piles with a length of 9 m and 4.5 m is about 1 cm, which could not cause actual over-deformation.

However, given the occurrence of “negative friction” effect due to self-compacting and mechanical suffusion in the upper layers of the bulk sands after rupture of the main thermal pipeline, which was intensified by inertial forces from the explosions in the quarry, the bearing capacity of the pile decreased to $F_d = 375.7$ kN, it is up to $N = 268.0$ kN, which is less than the vertical force from the structures of the building 404.5 kN.

When the permissible load on the pile was exceeded, the pile's foundation base settlement was already in the nonlinear stage, which led to the appearance and development of existing deformations of the building. Provided that if all the piles' tips reached the design mark, then, of course, such deformation would not occur.

Figure 9 – The vertical tie of the pile to geotechnical column according to SNIP 4.5 – 35

- reinforcement of the pile foundations of the left face block section in the I-II axes by underlaying at least 400 mm thickness of monolithic reinforced concrete slab under the existing grids. The underlaying of the slab must be done in four stages, starting from axis II, moving to axis I. To put the plate into operation as soon as it is performed, the base under the slab should be compacted by gravel and pounded with vibrating plates;
