Structural Features and Survey Results of the 18th-Century Illinska Church in Korop

Abstract. The article presents the results of a comprehensive study of the 18th-century Illinska Church located in the urban-type settlement of Korop, Chernihiv region, which is a valuable monument of Ukrainian Baroque architecture. The aim of the study was to identify the structural characteristics of the building and to determine the technical condition of its main elements. The research utilized archival materials that made it possible to reconstruct the history of construction and subsequent renovations, as well as data from on-site surveys conducted by the author during field expeditions. The main attention was focused on the analysis of the masonry walls, the wooden floor structure, and the metal tie rods that ensure the spatial rigidity of the building. It was established that the masonry consists of brick laid on a lime mortar and contains areas of material loss and wall cracking. The walls in the northern part of the church are 2 m thick, while those in the southern part are 1 m thick. The wooden structural elements of the floor are almost completely destroyed, with remaining fragments in

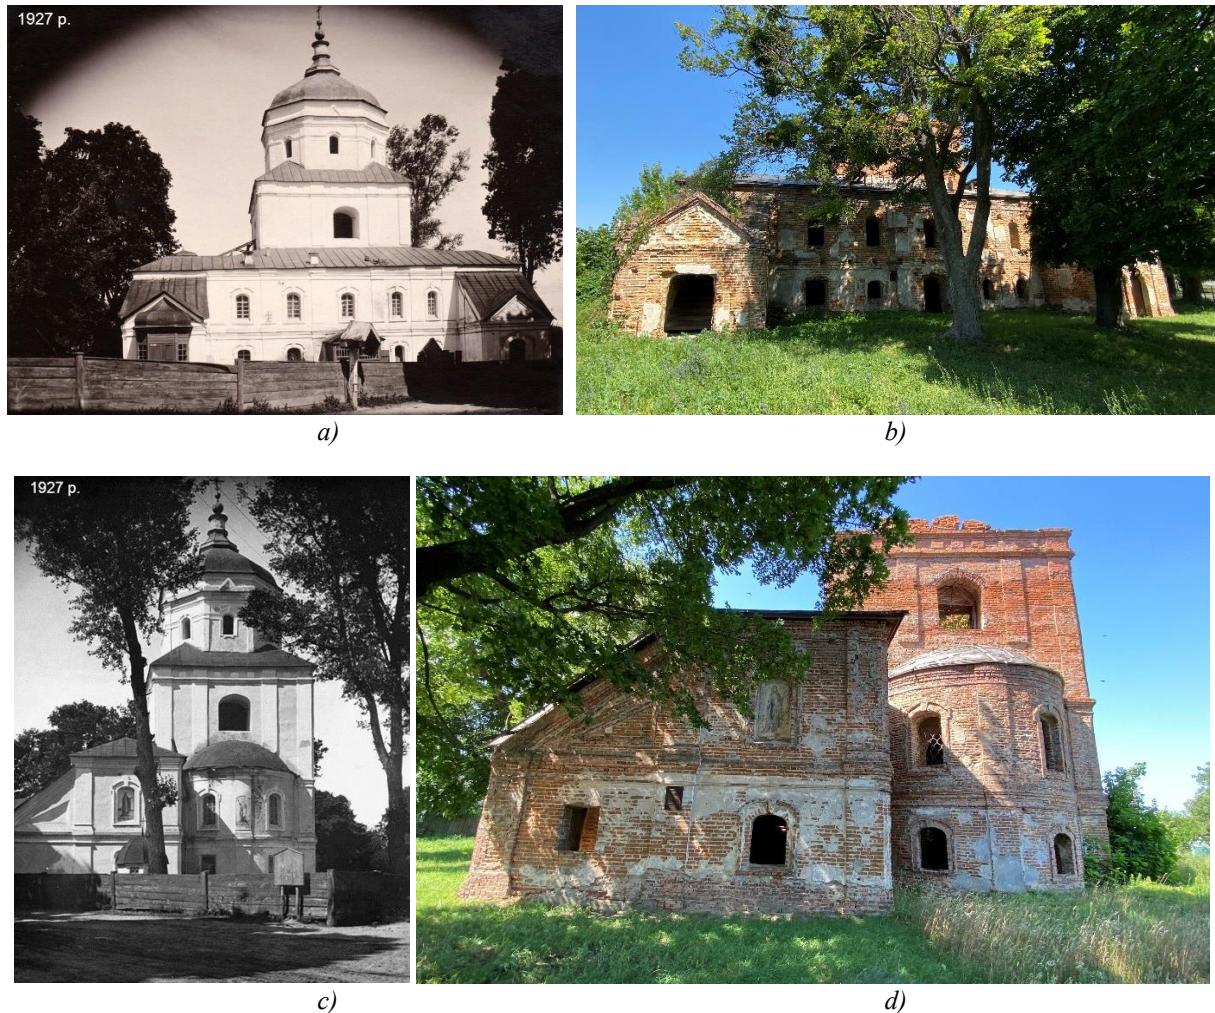
Figure 1 – Illinska Church in Korop:

Today the structure is in an emergency condition (Fig. 1). The building has not been used or maintained for an extended period, leading to accelerated physical deterioration. The exterior walls contain numerous cracks and deformation marks caused by environmental exposure. The brick masonry shows mortar loss, weathering, delamination, and local disintegration. Due to the absence of a watertight roof and drainage system, the walls and vaults undergo constant moisture saturation, resulting in dampness, efflorescence, and biological damage (moss, lichens). In areas with prolonged moisture accumulation, corrosion of metal components is observed.

a) – photograph from 1927, south view; b) – photograph from 2025, south view;
 c) – photograph from 1927, east view; d) – photograph from 2025, east view.

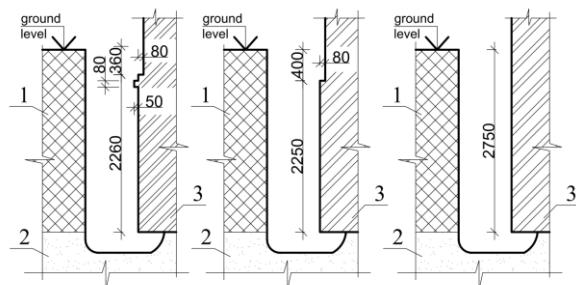
Based on the conducted investigations, it can be assumed that the original plinth level was located 40 cm below ground level (Fig. 2).

Figure 2 – Plinth level recorded during the test pits:
a) southwest wall;
b) northwest wall of the elongated part of the building;
c) northwest wall of the main part of the building
(plinth not recorded)

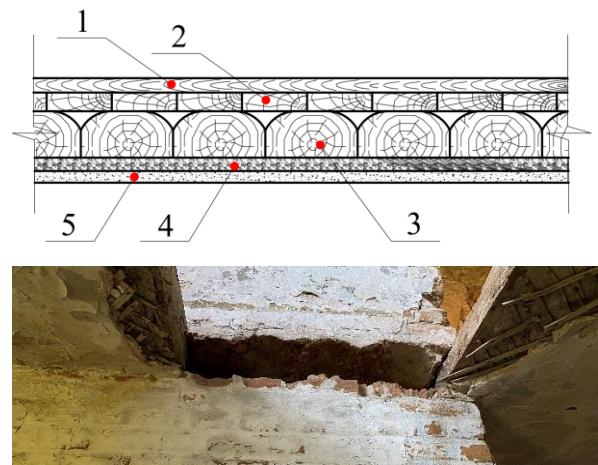
The floor structures above the first storey were originally flat wooden floors, almost completely lost today. The wooden beams forming the continuous subfloor were embedded 30 cm into the masonry. A rough plank flooring of 6.5 cm thick boards was laid

over the subfloor beams. The finished floorboards, 4.5 cm thick, were installed perpendicular to the rough boards (Fig. 3).

Figure 3 – First floor ceiling:
1 – finish floorboards, 4.5 cm thick;
2 – subfloor boards, 6.5 cm thick;
3 – joists, 30 cm wide, 22 cm high;
4–5 – lime plaster on lath

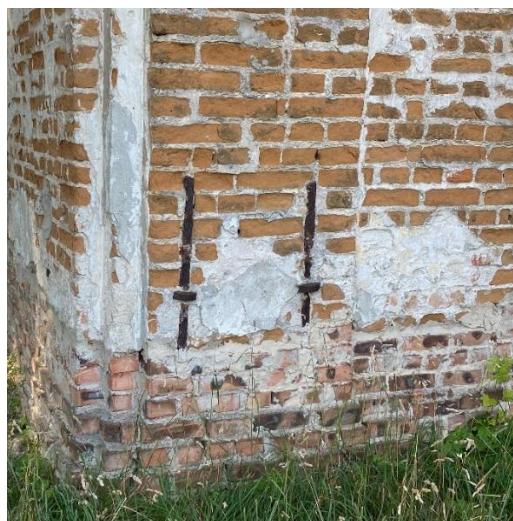
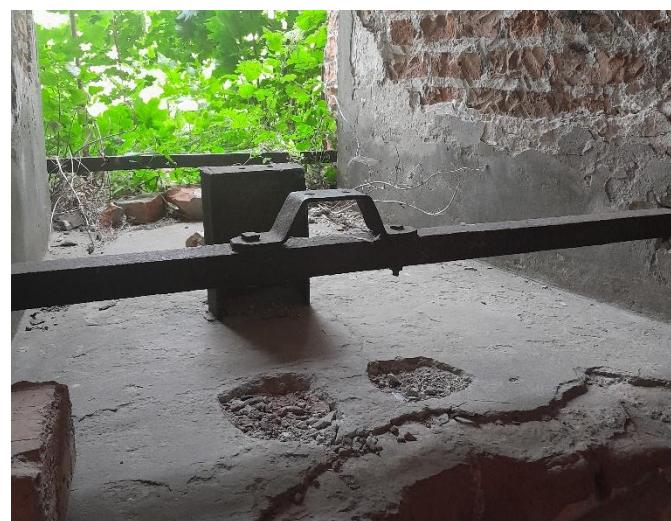
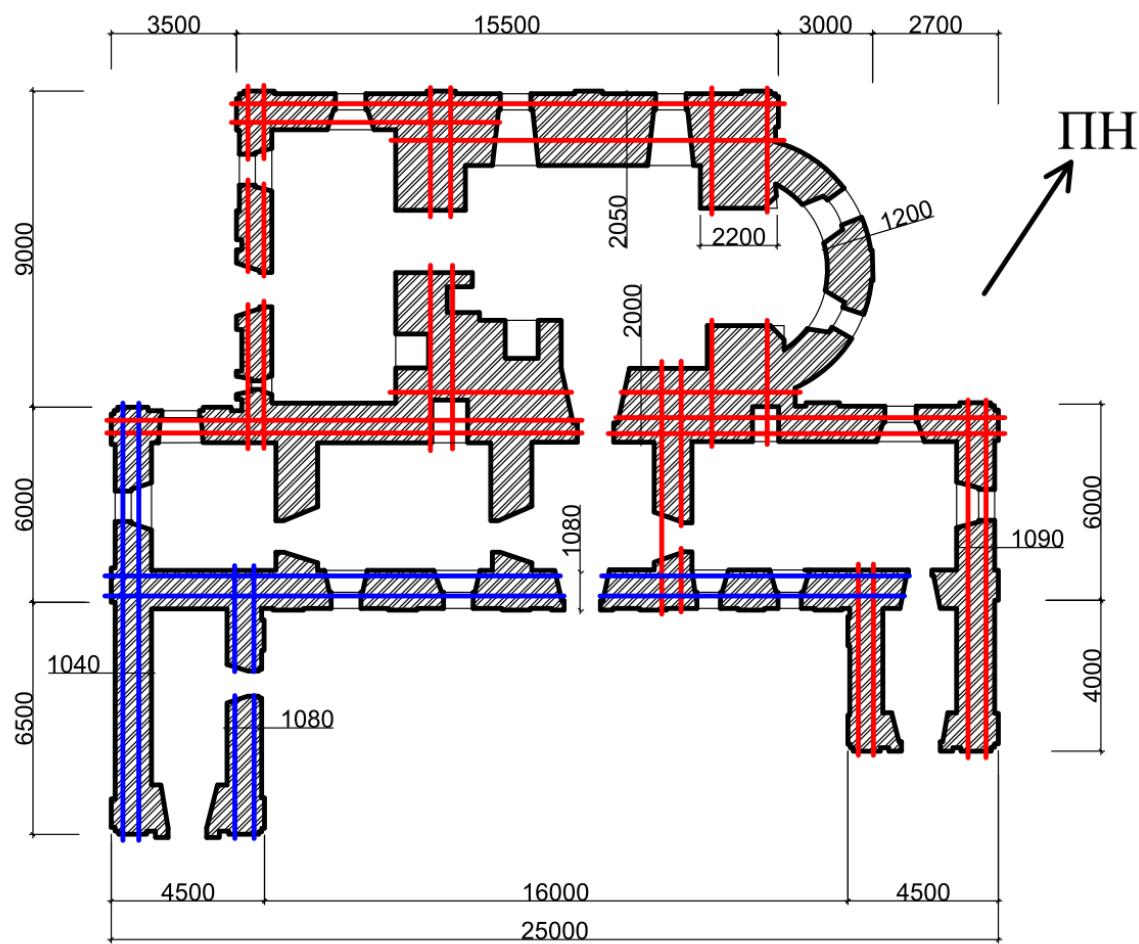
Of particular interest are the metal anchor tie rods embedded in the walls and the significant thickness of the walls themselves (Fig. 4). In some places, the anchor tie rods are cut off, and in certain sections, they pass through window openings.

The location of the anchor ties in the diagram is based on archival data and in-situ surveys; however, in some areas their exact position may remain undetermined. To clarify their placement, more detailed investigations using non-destructive testing instruments are required.

a) – anchor ties that protrude from the corner of the wall; b) – anchor ties that pass through the wall; c) – plan of the first floor, lines show tie: red – width 4 cm, height 4.5 cm; blue – width 7-8 cm, height 1.0-1.5 cm.

- Restoring foundations (reinforcement using injection grouts, bore-injection technologies, reinforced concrete casing);
- Securing and restoring brick masonry of walls (adding authentic bricks according to original samples, restoring metal ties);
- Restoring the first floor, wooden floors, and stairs;
- Restoring inter-floor structures (brick vaults; wooden floors);
- Restoring the tower volume;
