## Restoration measures for foundations of metal silos on degraded loess soils

**Main material and results.** In December 2022, a technical survey was carried out for a group of six silos at the Kononivskyi elevator facility in Pomyunnyk, Mankivka district, Cherkasy region (Fig. 1).

Each silo has a capacity of 7,760 m<sup>3</sup> and a diameter of 23.78 m. Structurally, the foundations consist of a ring foundation combined with a floor slab and an underground gallery.

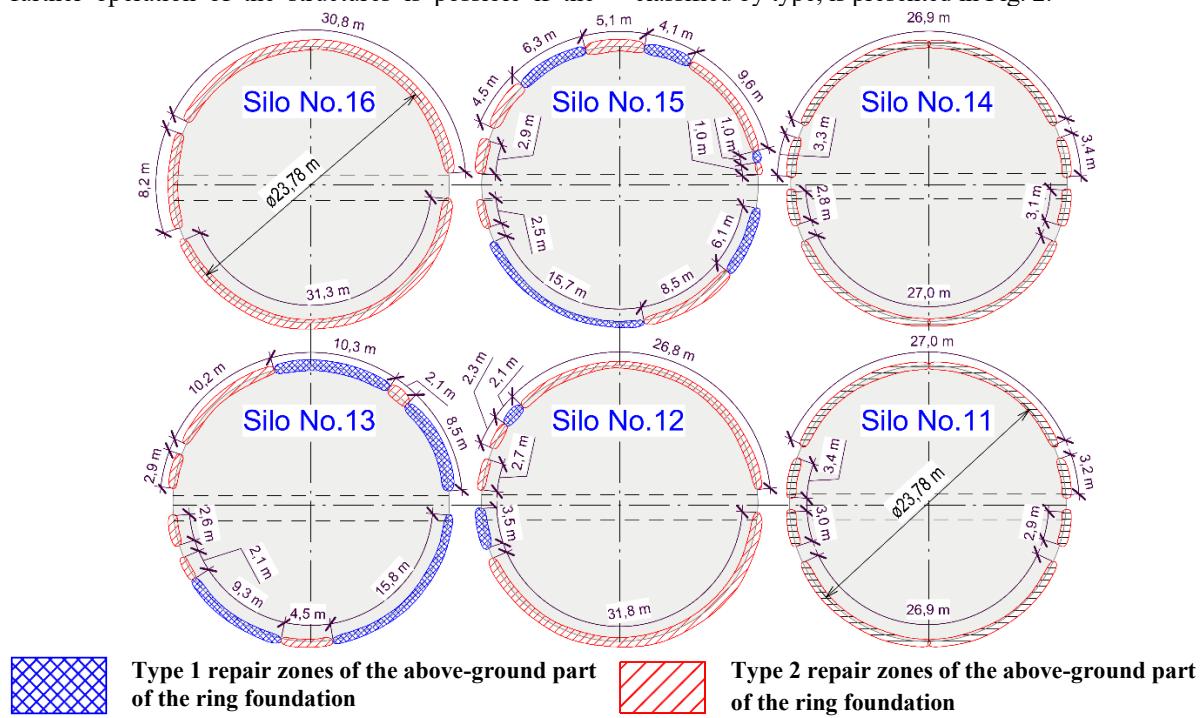
The concrete damage was conventionally classified into two types according to its extent and depth. The scheme of the identified defects in the ring foundation, classified by type, is presented in Fig. 2.

Type 1 damage is characterised by extensive (deep) concrete deterioration which, after removal of the damaged material, resulted in full exposure of the outer reinforcement layer along large portions of the foundation, as well as partial exposure of the anchor bolts. This represents deep structural damage. In cases of significant concrete loss and complete exposure of the

Type 2 damage is characterised by a relatively limited depth of concrete removal, which involves partial exposure of the foundation reinforcement and may include isolated areas of full exposure (Fig. 4). Most of the deterioration is confined to the concrete cover zone.

Before repairing the above-ground part of the ring foundation, the damaged concrete was removed to the depth of intact material, and any exposed reinforcement was cleaned of corrosion.

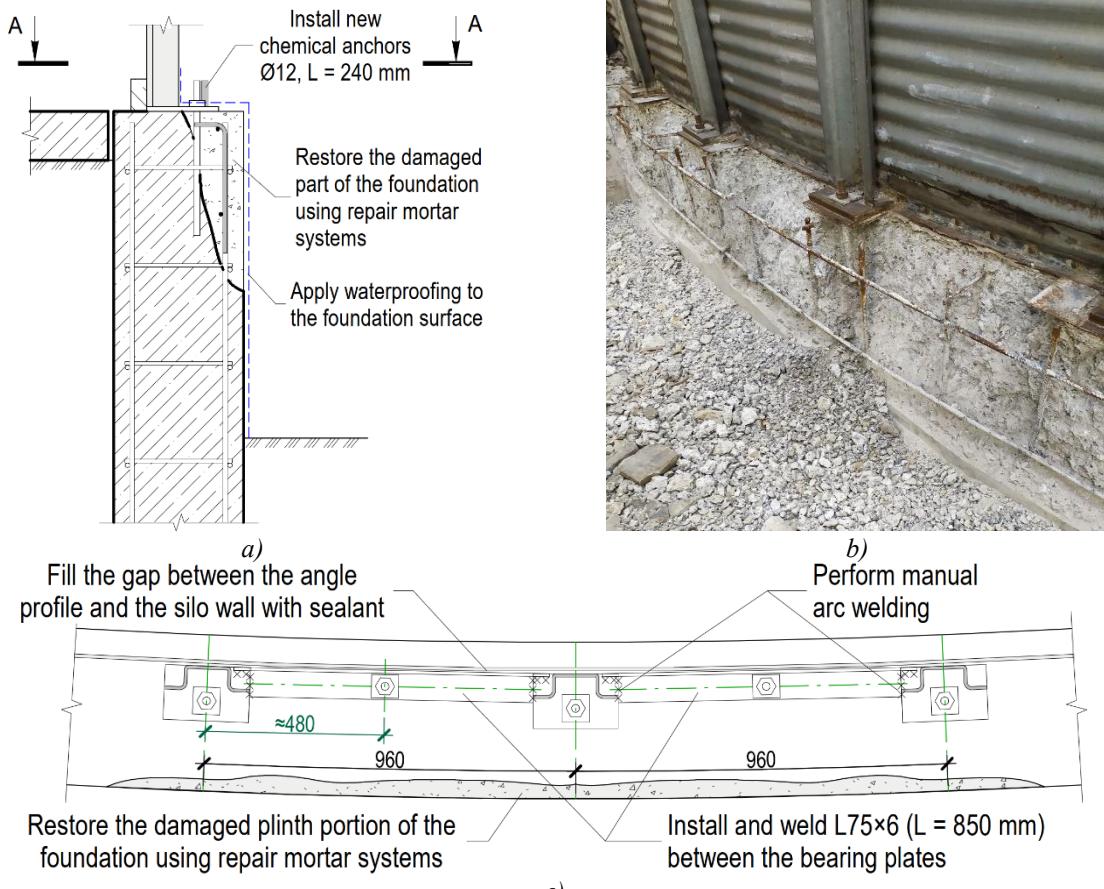
**Figure 3 – Above-ground part of the ring foundation after removal of Type 1 damaged concrete: a) design solution for restoring the damaged foundation segment; b) photograph of the foundation after removal of damaged concrete; c) design solution with increased number of anchor bolts**

The results showed that most of the base plates remain in compression, meaning that the anchor bolts do not experience tensile forces. At the same time, several zones form along the silo perimeter where groups of adjacent anchors are in tension. The average tensile force in these zones is  $P = 45 \text{ kH}$ . According to the procedure in [15], a single M24 anchor bolt can resist a design tensile force of  $N_{M24} = 48.6 \text{ kH}$ , which formally satisfies the strength requirement ( $P/N_{M24} = 0.925 < 1$ ). However, this check does not account for the reduced load-bearing capacity of the reinforced-concrete ring foundation due to the Type 1 damage previously identified.

bars, additional reinforcement was installed, with the new bars connected by spot welding (Fig. 3).

In view of this, for the areas with deep concrete damage (Fig. 3c), it was decided to install additional M12 anchor bolts on chemical anchors, arranged at half

spacing (480 mm). The design tensile capacity of a single M12 anchor is  $N_{M12} = 11.6 \text{ kH}$ , which increases the total load-bearing capacity of the connection to

$$\sum N = N_{M24} + N_{M12} = 60.2 \text{ kH}.$$

As a result, the load-to-capacity ratio decreases to  $P/\sum N = 0.748$ .

The adopted repair solutions for the anchor connection nodes are shown in Fig. 3 and Fig. 4.

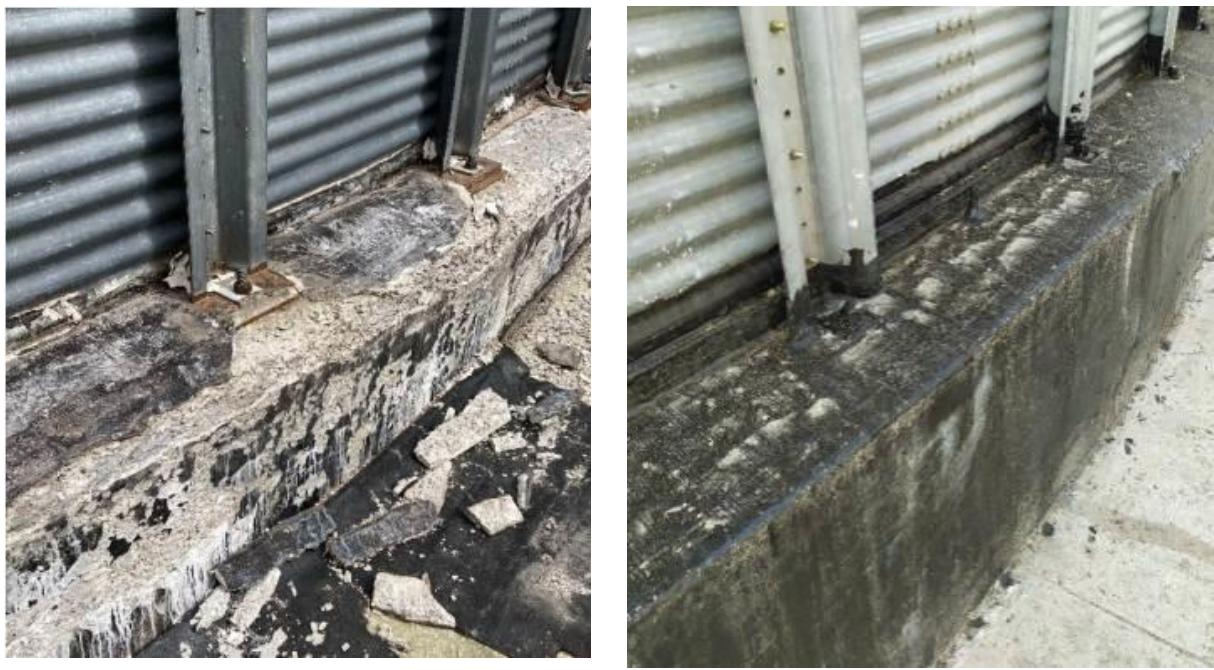
**Figure 5 – Waterproofing of the above-ground part of the silo foundation: a) before repair; b) after repair**

- extensive freeze-thaw damage to concrete in the above-ground part of the ring foundation;;
- detachment of the applied waterproofing on the above-ground part of the foundation;

After the local restoration of the reinforced-concrete elements, a horizontal and vertical coating system was applied to the above-ground part of the foundation using bitumen-based waterproofing (Fig. 5). The protective barrier is intended to limit moisture ingress into the concrete substrate and the reinforcement, thereby reducing the likelihood of renewed freeze-thaw deterioration and mitigating the risk of corrosion at the support interface of the steel silo structure.

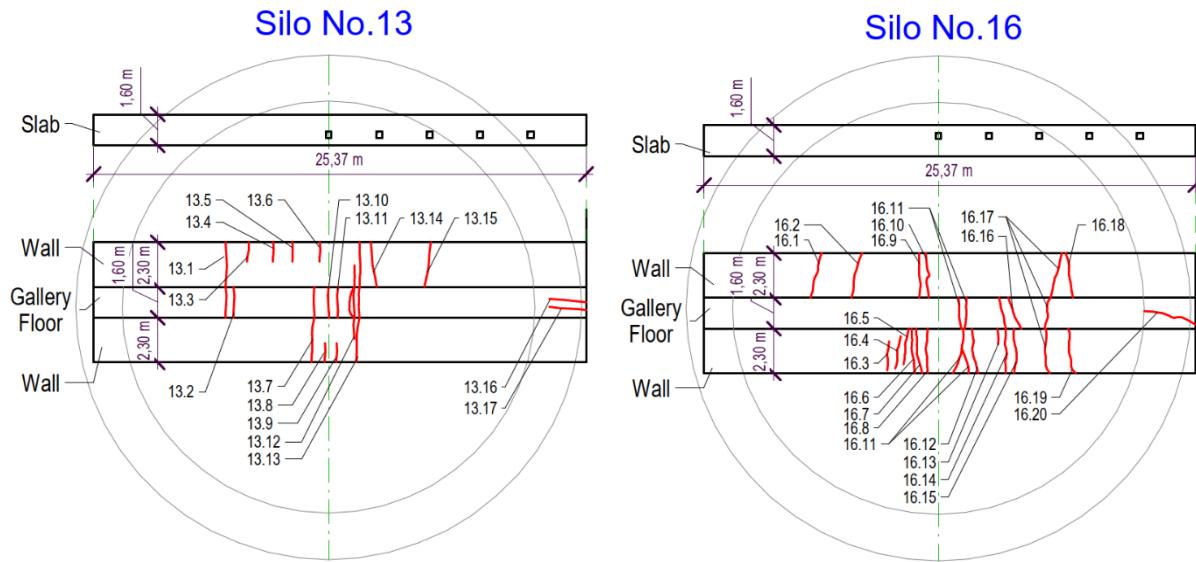
Figure 6 – Crack layout of the underground gallery for silos No. 13 and No. 16

documenting the transverse and inclined cracks in the walls and floor of the galleries for all silos. Figure 6 presents the crack layout for the galleries of silos No. 13 and No. 16. The crack pattern and orientation indicate that the primary causes are poorly compacted

backfill beneath the floor slab, which leads to stress redistribution and overloading of the underground gallery [10], as well as uneven local wetting of the collapsible soil foundation.

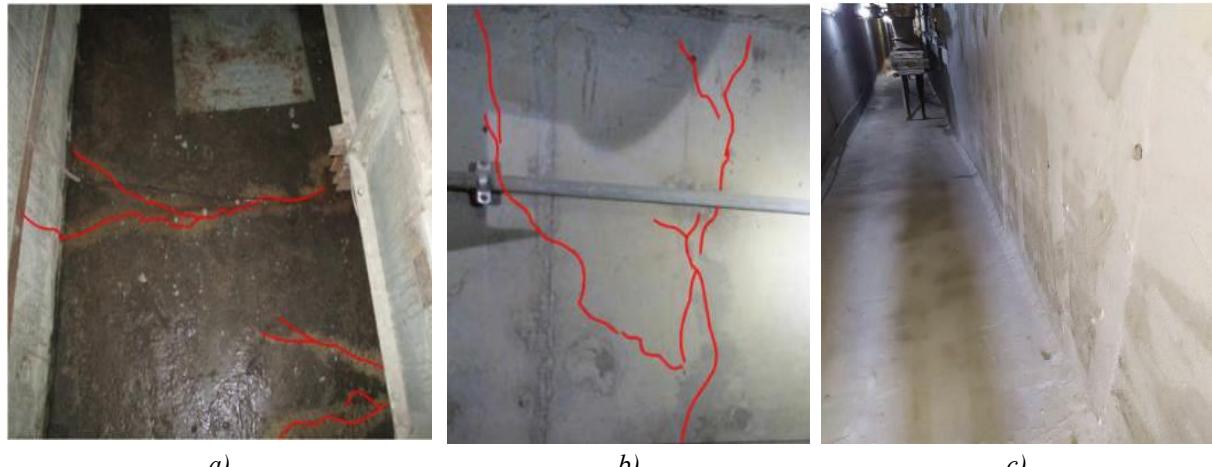
Figure 7 – Condition of the underground galleries: a) floor cracks as recorded during the survey; b) wall cracks as recorded during the survey; c) walls and floor after completion of the repair works

- numerous vertical and inclined cracks in the floor and walls of the underground gallery;
- significant height differences (up to 7 cm) between adjacent blocks at the vertical expansion joints of the underground galleries;

To restore the serviceability of the structure, including its stiffness, integrity and watertightness, the cracks were injected with the polymer resins HydroBloc PU 500 and HydroBloc Rapid 570. These materials provide strong adhesion to the mineral substrate and sufficient mechanical performance to operate under the existing non-uniform deformations. The injection was carried out in the actual deformed state of the structure, which was taken as the baseline condition for the repair works. The repair did not include modifying the geometry or re-levelling the gallery. Restoration was achieved through crack sealing, local stiffness enhancement in weakened zones and re-establishing the continuity of the structural section (Fig. 7).

This approach made it possible to stabilise the gallery in its existing SSS and to ensure its continued compatible behaviour with the other foundation elements. The effectiveness of the applied measures was confirmed by subsequent geodetic observations within the geotechnical monitoring programme [12].

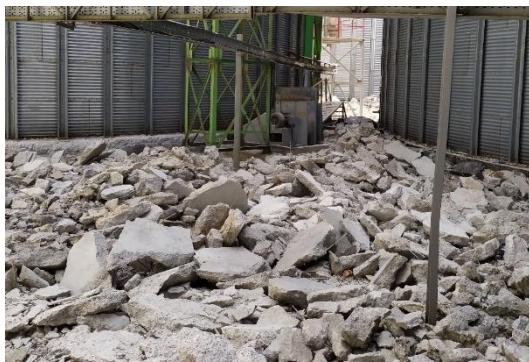
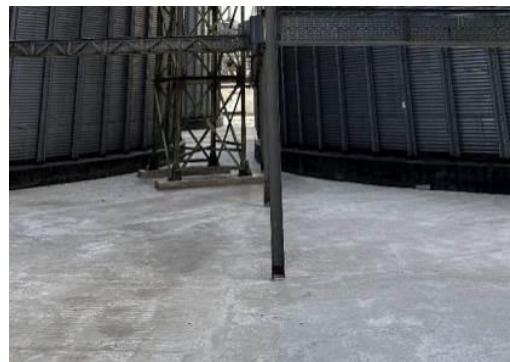
**Figure 8 – Pavement around the silos: a) removal of the old pavement; b) new pavement**

- recurrent flooding of the underground gallery due to poorly executed expansion joints;
- design errors related to the site’s drainage system;
- extensive damage to the concrete pavement around the group of six silos, including settlements, cracking, and voids beneath the pavement;

The final stage of the restoration and service-life extension measures for the silos was the complete replacement of the existing concrete pavement with a new one. This included forming the required slopes and regrading the pavement to ensure effective surface drainage within the silo area.
