Features of reinforcing and repairing building structures after prolonged exposure to moisture

The university dormitory building, constructed in 1962, is the subject of a major renovation. An inspection of load-bearing elements and defective areas was conducted as part of a project to thermally modernize dormitories and academic buildings. The building's total height is 15.7 m; it has five stories, including the basement. The building's dimensions are 29.8 x 58.8 m; the height of the living quarters is 2.5 m, and the height of the basement is 2.6 m. An inspection of the existing structural condition was conducted in 2024 prior to the development of design and cost estimate documentation.

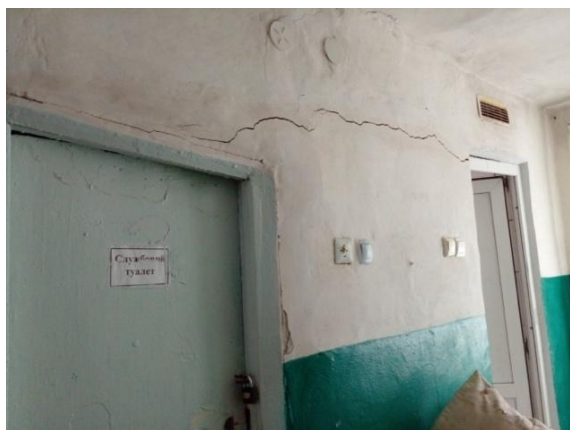
The brick walls (partitions) in the shower rooms and restrooms on the first floor are classified as Technical Category 3—unsuitable for normal use. This is caused by soil subsidence beneath the foundations of the partitions, resulting from leaks in the water supply and sewer lines (Fig. 1).

Figure 1 – Horizontal cracks on the walls

The destruction of the walls is caused by leaks in the drainage systems, which are made of cast iron and, according to the survey results, require immediate replacement. The leaking pipes contributed to the process of soil suffusion under the foundations of the partitions and walls of the sanitary block. Constant soil saturation around the brick structures caused moisture accumulation in the walls, leading to frost-induced destruction of the bricks and loss of adhesion with the exterior plaster layer.

For the same reason, floor deformation and warping of door jambs have been noted. It is recommended to dismantle the partitions, remove the floor and subfloor, replace the water supply and sewer lines, and restore the partitions and floor. During the preliminary technical inspection of the floors (visual), restoration of the composite floor layers was planned.

The major renovation project involved replacing utility lines, removing partitions, replacing the floor subfloor, and rebuilding the partitions.

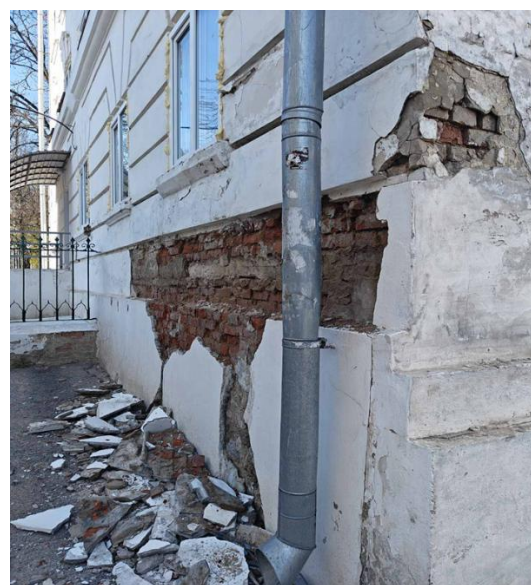
The exterior brick walls are 640 mm thick. At the time of the demolition work, the portion of the wall that is buried in the ground on the interior side—and which forms a foundation with a ground level of 1.000 m on the exterior—has through cracks. The exterior finish layer has lost adhesion to the brickwork, which shows signs of frost-induced damage, damage extending to a depth of up to 50 mm, and damage to the mortar (Fig. 2). The measured moisture content of the brick on the plinth side was 35–40%, and that of the mortar between the bricks was up to 50%.

Figure 2 – Peeling of the plaster layer on the foundation and frost damage to the bricks

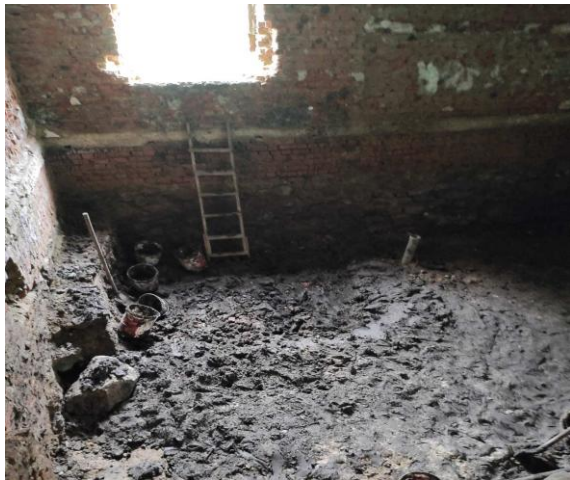
The condition of the structures following the demolition work revealed that it was not possible to implement the design solution—restoring the floor directly on the ground (Fig. 3).

Figure 3 – Photographic documentation of water-saturated soil beneath the shower floor to a depth of 2.5 m from the 0.000 level

It was decided to leave the crawl space open and install a monolithic floor slab above it. The ventilated crawl space will allow the water-saturated brick walls to dry out. However, constructing a monolithic floor slab supported by structures deemed unfit for normal operation required their reinforcement and careful monitoring of their condition at all stages of construction.

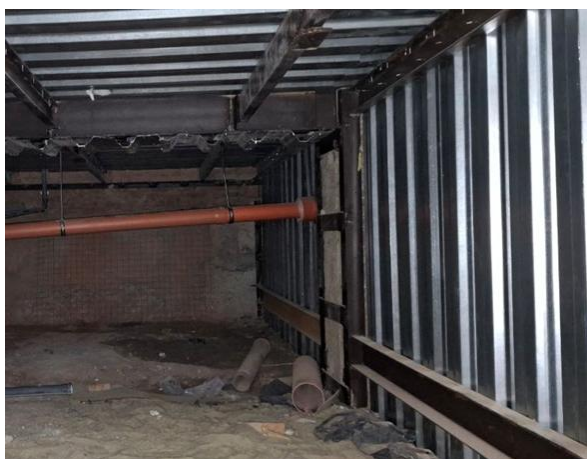
The 120-mm-thick interior partitions collapsed during the removal of the finish layer due to constant water saturation.

Figure 4 – General view of the basement with the interior brick wall reinforced by a layer of reinforced concrete using permanent formwork

After excavating the wet soil, it was recommended to reinforce the brick walls with a vertical monolithic concrete layer with prior reinforcement (Fig. 4).

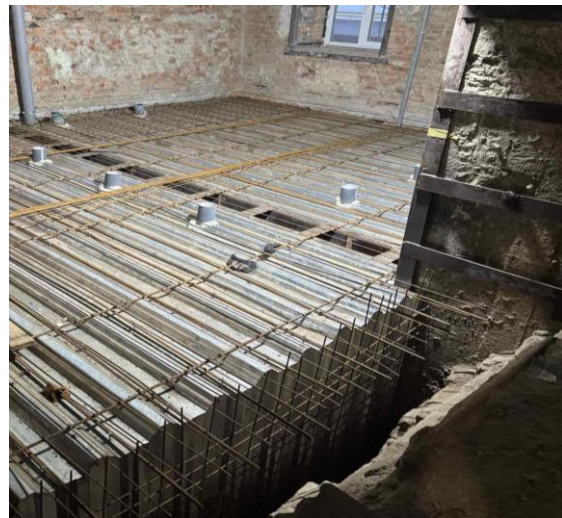
Figure 5 – Stages of floor construction

The primary technical solution adopted to restore the serviceability of the shower block floor is a composite steel-reinforced concrete floor using channel sections, profiled sheet metal, and concrete. This

solution minimizes the structure’s dead weight and ensures rapid installation within the confined space of the old building (Fig. 5).

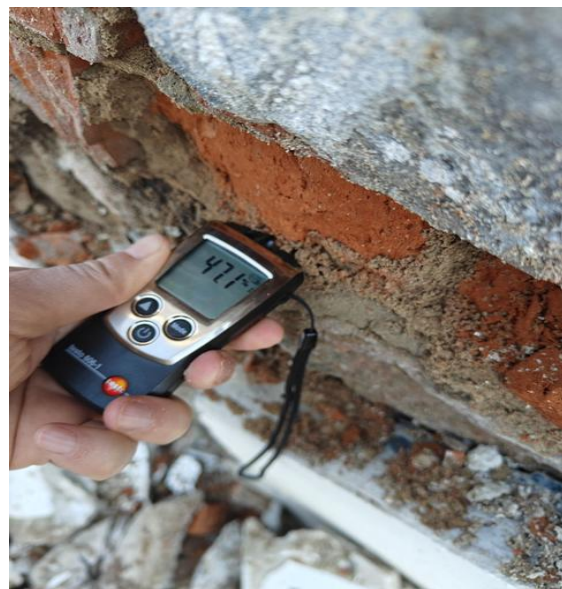
Field measurements of the brick wall’s moisture content were taken between 2025 and 2026 to track the drying process. The test areas included the inner and outer surfaces of the exterior brick wall and the surface of the interior wall. Measurements were taken using a Testo material moisture meter. This is a portable electronic device designed for the rapid and accurate determination of the moisture content in wood, building materials (concrete, brick, plaster), and air (Fig. 6).

Figure 6 – Photos of moisture measurements of mortar and basement bricks

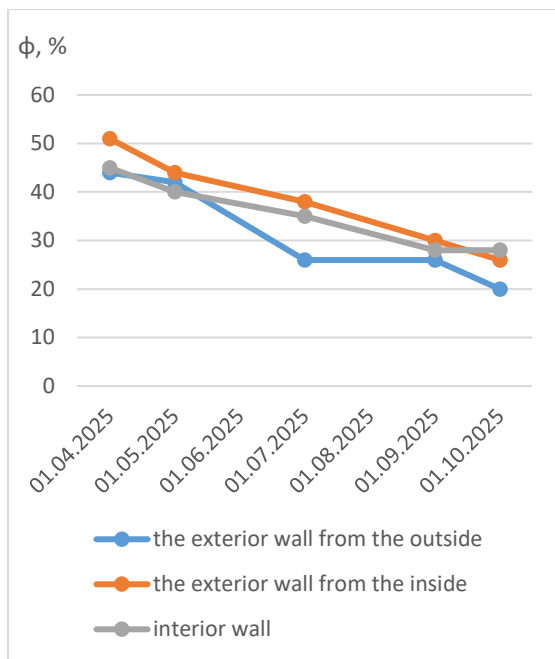
Figure 4 – Graph showing changes in the moisture content of a brick wall

Field studies of the moisture content of brick walls over the course of a calendar year revealed a trend of decreasing moisture content in the bricks and mortar

when a new floor design—featuring a technical crawl space—was implemented.
