## Structural Features and Survey Results of the 18th-Century Illinska Church in Korop

**Abstract.** The article presents the results of a comprehensive study of the 18th-century Illinska Church located in the urban-type settlement of Korop, Chernihiv region, which is a valuable monument of Ukrainian Baroque architecture. The aim of the study was to identify the structural characteristics of the building and to determine the technical condition of its main elements. The research utilized archival materials that made it possible to reconstruct the history of construction and subsequent renovations, as well as data from on-site surveys conducted by the author during field expeditions. The main attention was focused on the analysis of the masonry walls, the wooden floor structure, and the metal tie rods that ensure the spatial rigidity of the building. It was established that the masonry consists of brick laid on a lime mortar and contains areas of material loss and wall cracking. The walls in the northern part of the church are 2 m thick, while those in the southern part are 1 m thick. The wooden structural elements of the floor are almost completely destroyed, with remaining fragme

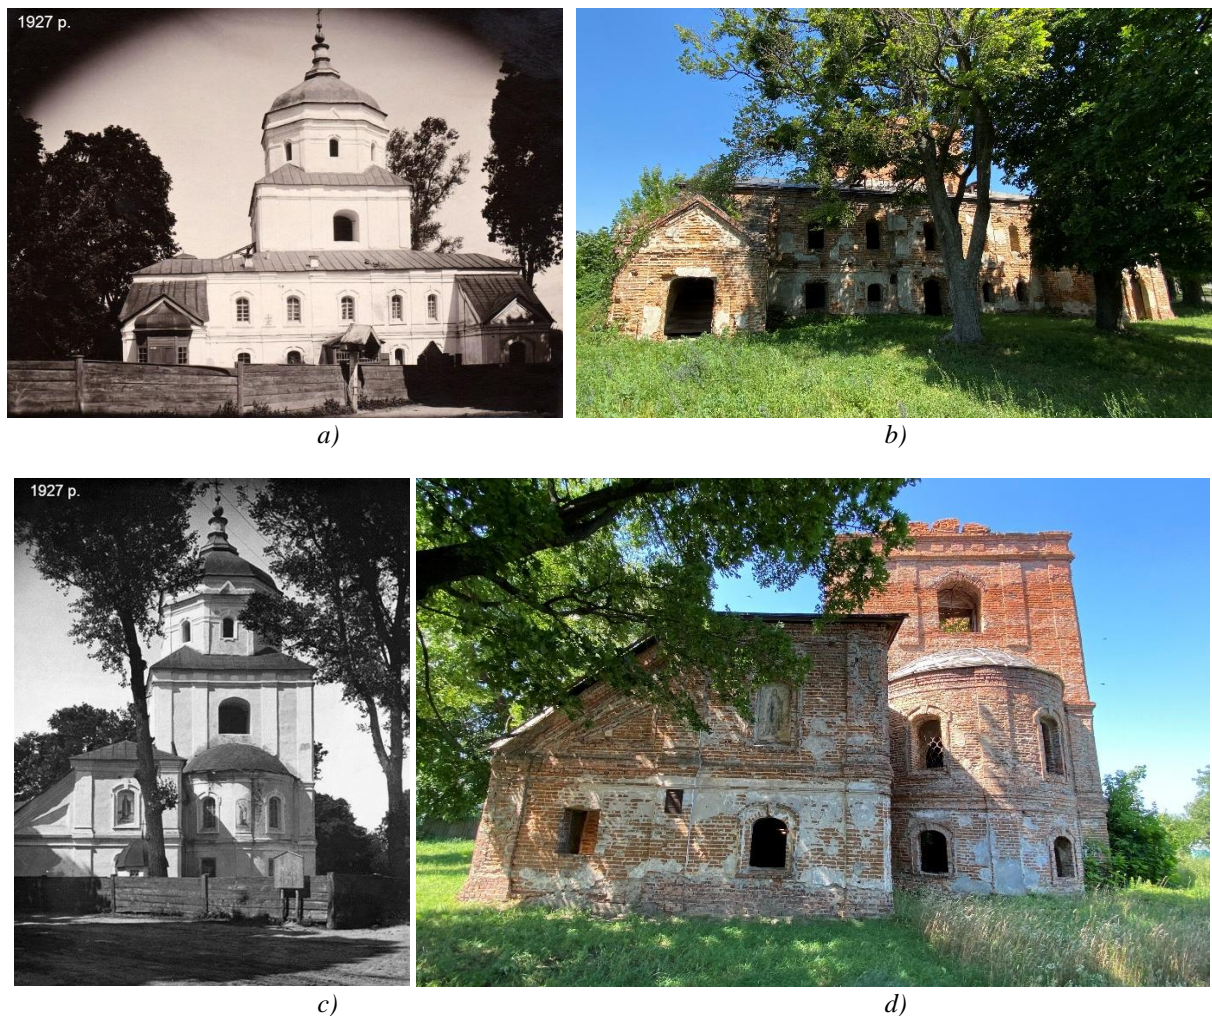
**Figure 1 – Illinska Church in Korop:**

Today the structure is in an emergency condition (Fig. 1). The building has not been used or maintained for an extended period, leading to accelerated physical deterioration. The exterior walls contain numerous cracks and deformation marks caused by environmental exposure. The identified deformations may indicate a gradual loss of spatial stiffness and the development of local instability mechanisms characteristic of historic masonry structures with multi-stage construction evolution [11].

The brick masonry shows mortar loss, weathering, delamination, and local disintegration. Due to the absence of a watertight roof and drainage system, the walls and vaults undergo constant moisture saturation, resulting in dampness, efflorescence, and biological damage (moss, lichens). In areas with prolonged moisture accumulation, corrosion of metal components is observed.

**a) – photograph from 1927, south view; b) – photograph from 2025, south view;  
c) – photograph from 1927, east view; d) – photograph from 2025, east view.**

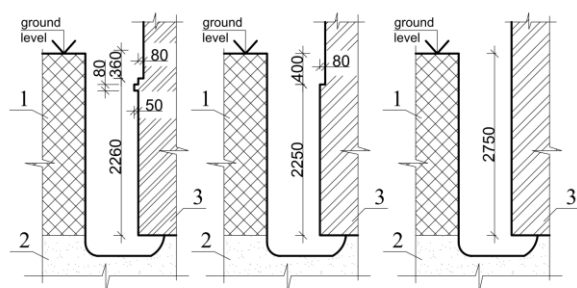
Based on the conducted investigations, it can be assumed that the original plinth level was located 40 cm below ground level (Fig. 2).

**Figure 2 – Plinth level recorded during the test pits:**  
a) southwest wall;

- b) northwest wall of the elongated part of the building;  
c) northwest wall of the main part of the building (plinth not recorded)

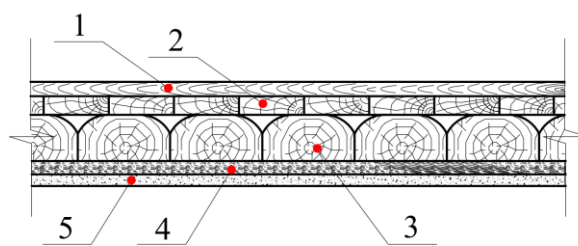
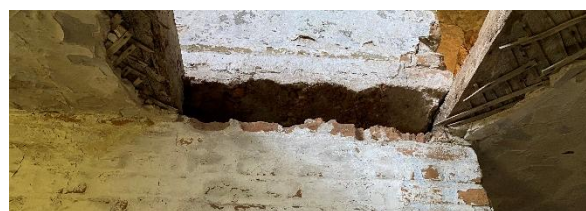
The floor structures above the first storey were originally flat wooden floors, almost completely lost today. The wooden beams forming the continuous subfloor were embedded 30 cm into the masonry. A rough plank flooring of 6.5 cm thick boards was laid over the subfloor beams. The finished floorboards, 4.5 cm thick, were installed perpendicular to the rough boards (Fig. 3).

**Figure 3 – First floor ceiling:**  
1 – finish floorboards, 4.5 cm thick;  
2 – subfloor boards, 6.5 cm thick;  
3 – joists, 30 cm wide, 22 cm high;  
4–5 – lime plaster on lath

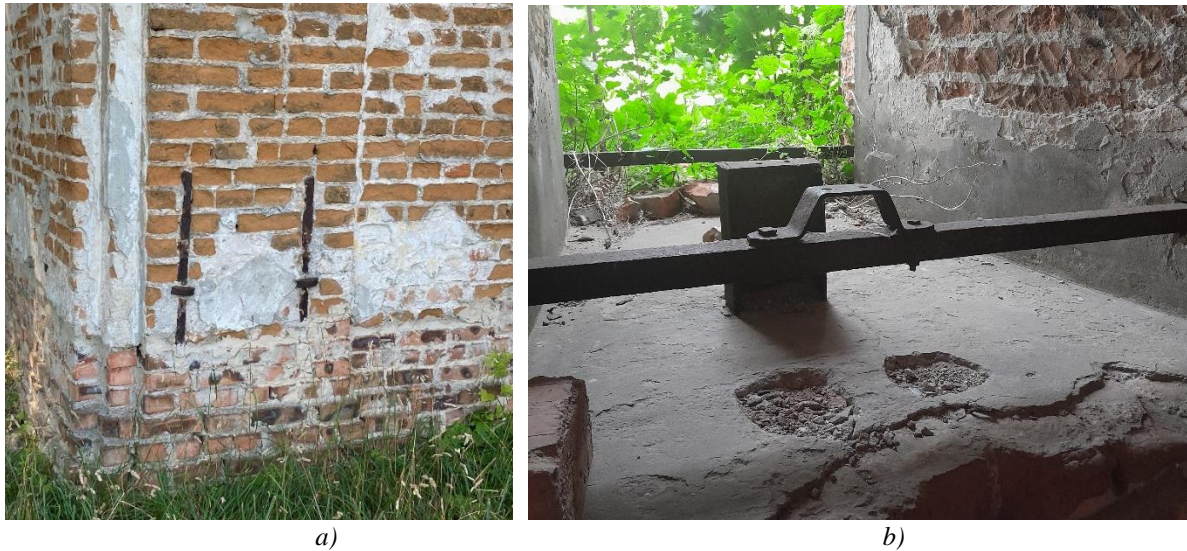
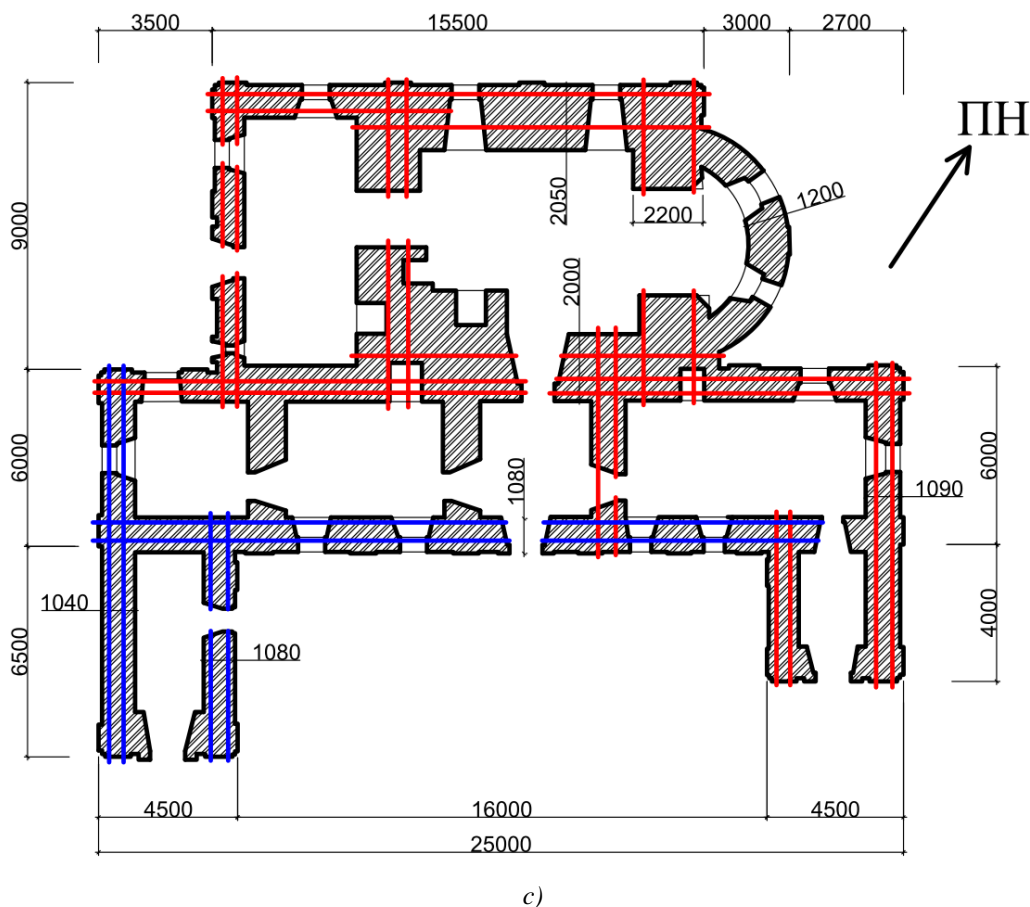
Of particular interest are the metal anchor tie rods embedded in the walls and the significant thickness of the walls themselves (Fig. 4). In some places, the anchor tie rods are cut off, and in certain sections, they pass through window openings.

The location of the anchor ties in the diagram is based on archival data and in-situ surveys; however, in some areas their exact position may remain undetermined. To clarify their placement, more detailed investigations using non-destructive testing instruments are required.

**Figure 4 – Anchor ties:**  
 a) anchor ties extending toward the northern corner;  
 b) anchor ties passing through the window of the northern wall;  
 c) first-floor plan with anchor ties indicated by lines: red lines denote ties 4 cm wide and 4.5 cm high;  
 blue lines denote ties 7–8 cm wide and 1.0–1.5 cm high.
