Changes in the Stress-Strain State of Precast Reinforced Concrete Floor Systems in Masonry Multi-Storey Buildings after Non-Design Impacts

The object of the study is the precast reinforced concrete floor system of the residential building located in Chernihiv, which was damaged as a result of shelling during military actions. Information regarding the technical condition of the building and its structural elements, its general characteristics, and the results of the inspection were taken from the “Report on the Detailed Survey of the Residential Building in Chernihiv, damaged as a Result of Military Actions,” prepared by the State Research Institute of Building Structures (NDIBK) in 2022.

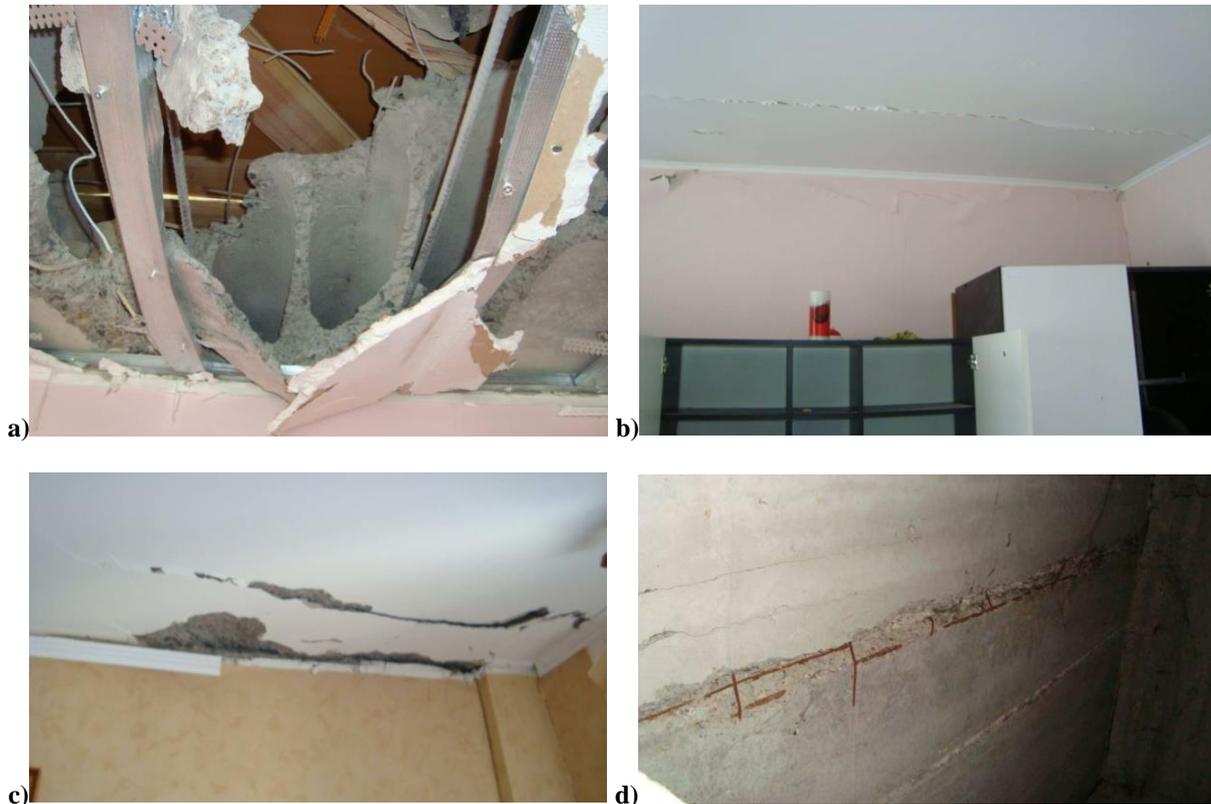
Figure 3 (a-d) – Identified damages of the precast reinforced concrete floor systems

Numerous damages to the precast reinforced concrete floor systems were observed. These damages occurred due to mechanical non-design impacts caused either by direct artillery shell hits on the floor slabs or on the load-bearing wall structures, with the impact energy subsequently transmitted from the wall to the floor system. The observed damages include complete destruction of hollow-core floor panels, cracks at the

joints between floor slabs, cracking of the finishing layer, through-holes in the hollow-core panels, spalling of the concrete cover with exposure and corrosion of reinforcement, cracks and deflections at panel connections, and cracks in the joints between floor slabs (see Fig. 3).

In the case of the residential building in Chernihiv, which was damaged due to military actions, it is recommended that, in order to restore the serviceability and ensure reliable and safe future operation of the floor systems, the following measures be carried out: temporary strengthening of the emergency sections of the floor slabs and lintels by installing temporary props with wedging to engage them according to the scheme shown in Fig. 6; safe dismantling of completely destroyed elements; repair works to restore the brick masonry of damaged wall sections and strengthen the lintels; and restoration of the damaged floor slab sections by concrete casting, ensuring composite action of the reinforcement

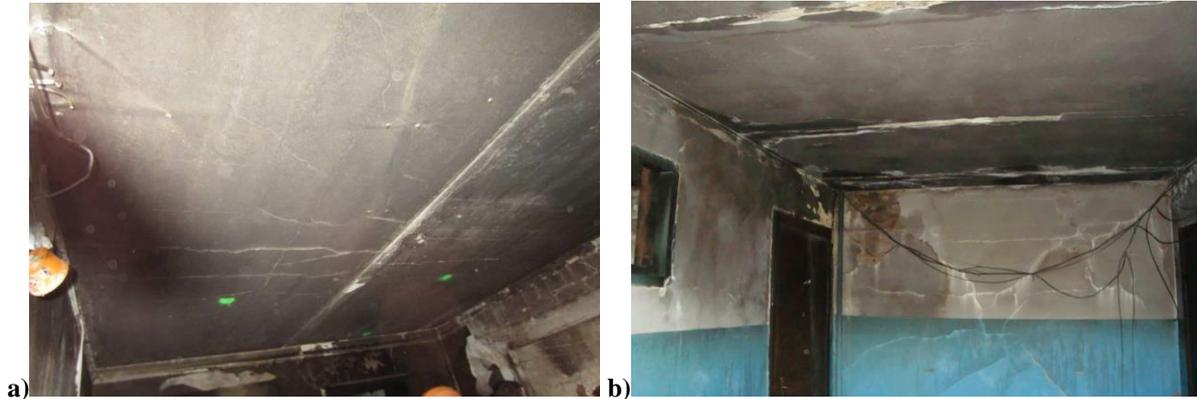
Some floor slabs experienced thermal deformations resulting from fires caused by artillery shell impacts. Cracking of the finishing layer and soot deposits were observed (see Fig. 4).

Figure 4 (a-b) – Cracking of the finishing layer and soot on the floor slab structure

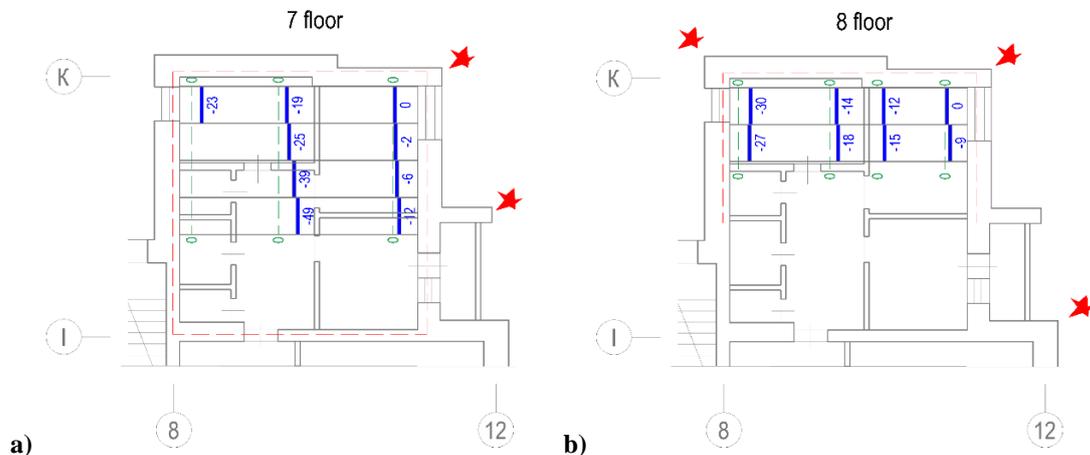
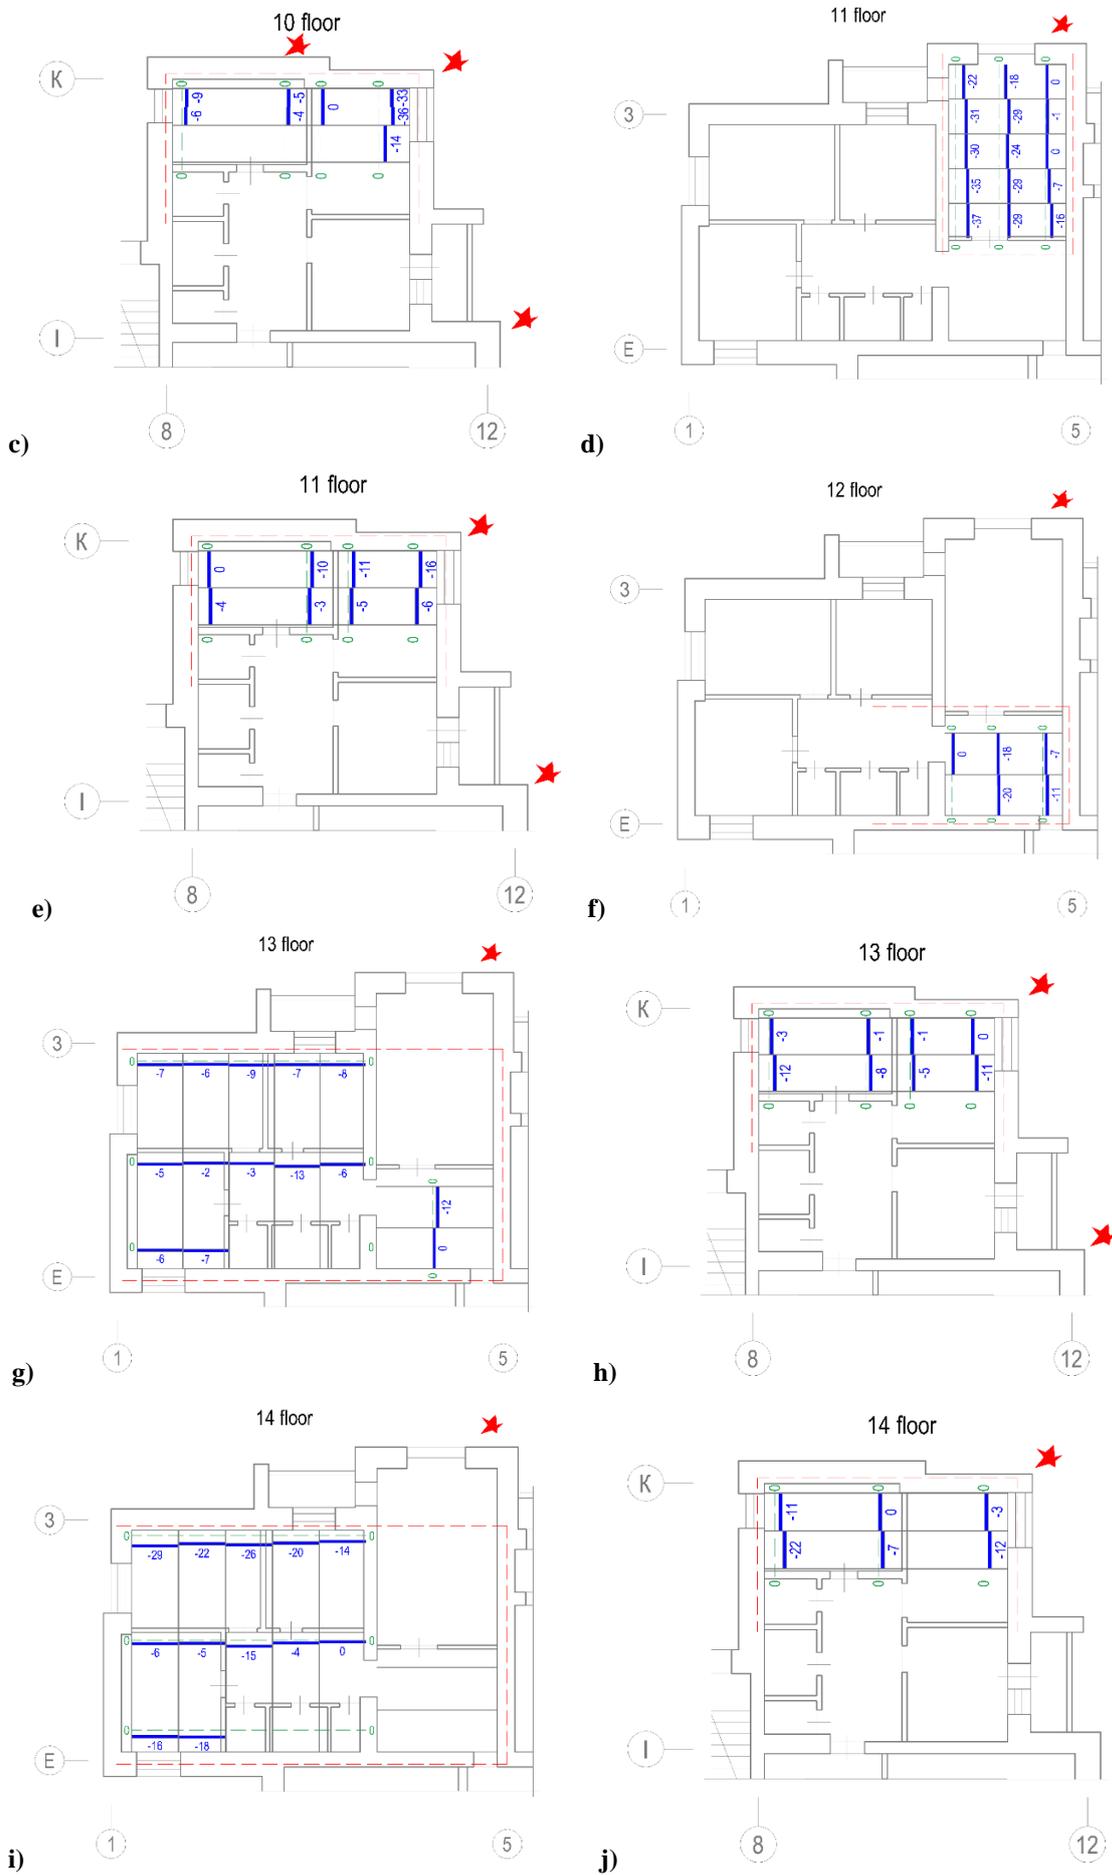
According to the geometric leveling results, an excessive deviation of -49 mm was recorded in the slab at axes K-I/8-12 on the 7th floor. In this area, damages and destructions of interior partitions, collapse of brick masonry at the junction of load-bearing walls, a through-hole in a load-bearing wall caused by a direct artillery shell impact, and other damage to interior partitions with vertical displacements were observed. No direct artillery hits on the floor slab or fire-related effects were detected in this location.

The remaining measured slabs were within permissible deviations. During two observation cycles (August–September), vertical displacements up to -1 mm were recorded, which did not exceed the measurement accuracy. In one section, a minor upward movement of +2 mm was observed, likely due to the unloading of the floor slabs.

Figure 5 (a-b) – Results of deviations from reference horizontal plane of the floor slabs (beginning)

Figure 5 (c-j) – Results of deviations from reference horizontal plane of the floor slabs (completion)
