## Moisture protection of structures adjacent to the ground in historic buildings

**Keywords:** foundation, basement floor, moisture, mold

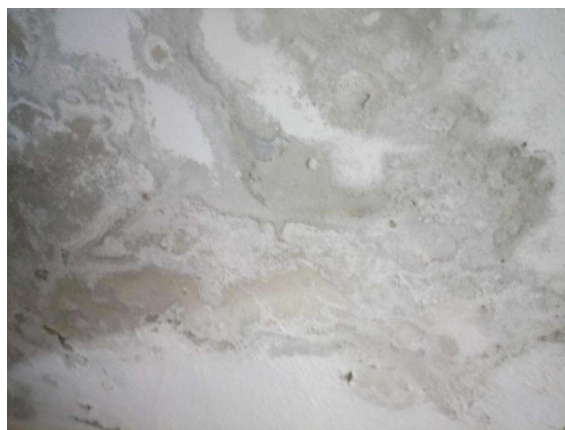
Repair and restoration works of the lyceum building were carried out in 2017-2018. Works on the complete replacement of the internal and external finishing layers of the walls were completed. Before restoring the plaster layer, the wall surface was hydrophobized. A year later, when the authors of the article examined the load-bearing walls of the premises on the first floor, 80% of the perimeter of the surfaces of the inner and outer walls revealed detachment of the plaster layer and the impression of a fungus. On the new plaster layer, efflorescence and traces of wetting are observed (Fig. 1).

**Figure 1 – Destruction of the plaster layer due to capillary moistening of foundations**

Considering that the institution building was built more than 200 years ago, the horizontal layer of waterproofing has exhausted its normative service life since the time of construction. The increase in the cultural layer of soil around the house has led to the fact that the level of the floor (from the yard) is lower than the level of the daily surface of the soil. In both cases, this leads to the moistening of the brickwork of the foundations, the basement, and the walls of the first floor due to the pulling of capillary moisture from the soil.

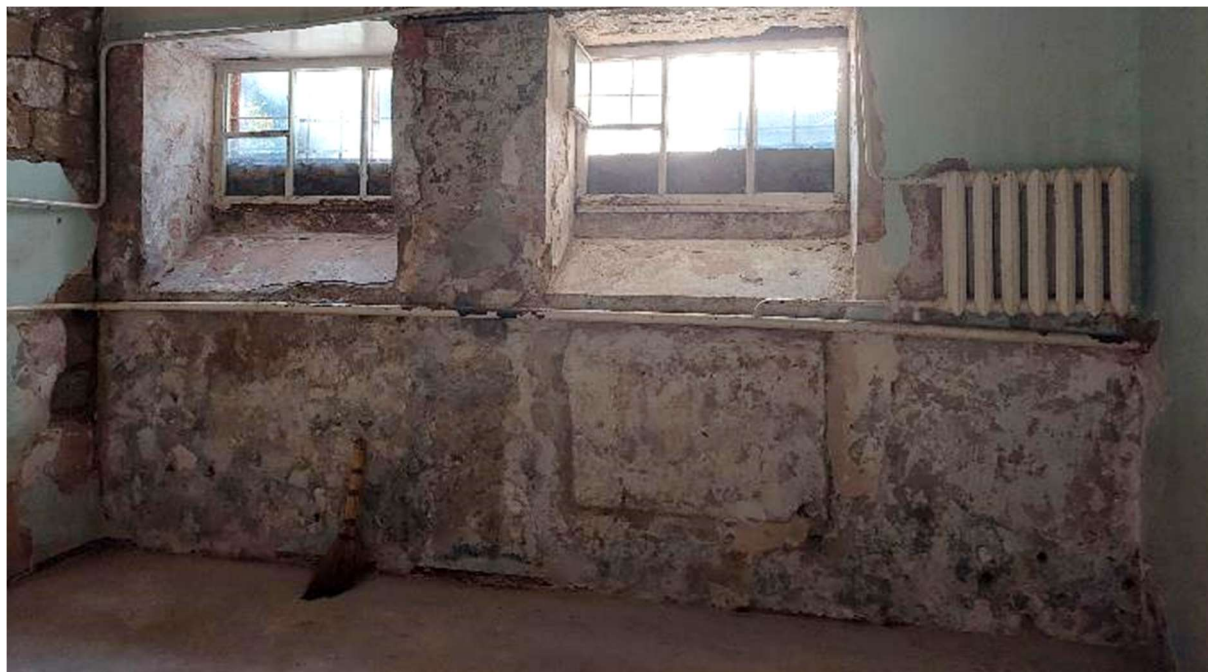
Soaking of basement walls observed. Frost destruction was recorded in places where once damaged spillways were installed and in the basement, soaked as a result of the formation of drainless areas around the building.

**Figure 2 – Destruction of the inner surface of the walls of the basement room due to the rise of capillary moisture**

To restore the horizontal waterproofing layer of all load-bearing brick walls, it is recommended to inject hydrophobic solutions into the structure at the floor level of the first floor in a continuous strip.
