Assessment of the technical condition of cave complexes

Keywords: cave, underground structure, survey, technical condition, increase

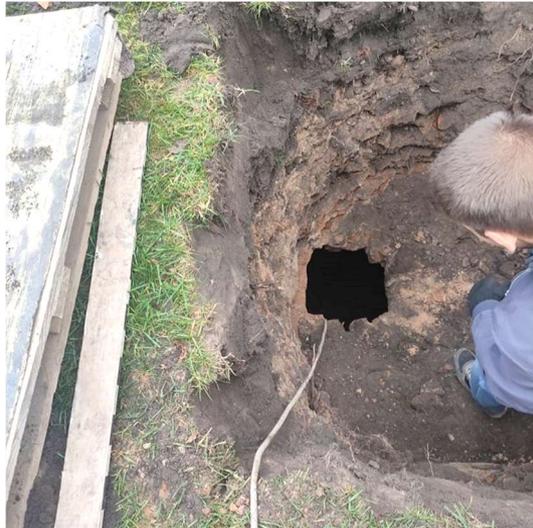
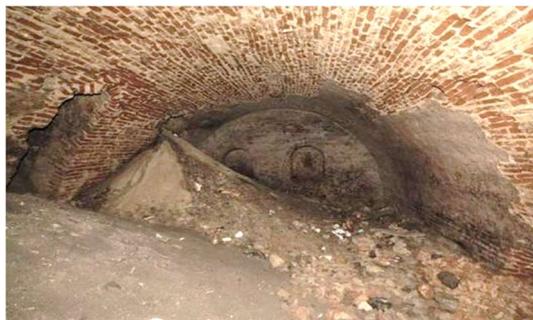
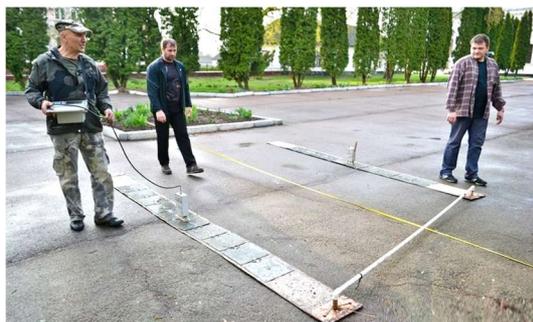
Figure 1 – Dungeons in Nizhyn:

- a – failure to the underground premises <https://cutt.ly/pXahO6K>;
- b – one of the underground premises <https://cutt.ly/2XahS7v>;
- c- GPR control <https://cutt.ly/bNmMMhv>

Numerous sinkholes that occur in various sections of the old Sednev and some records of underground galleries and cellars also remained unexplored. After the formation of the precipice in 2002, underground tunnels and premises (some 4 m high) were discovered near the All Saints Church in Nizhin, with an area of about 200 m². In 2021, during the reconstruction of Gogolya Street, the basement of the former building of the noble assembly at the end of XVIII was discovered while observing the laying of a drainage well (Fig. 1).

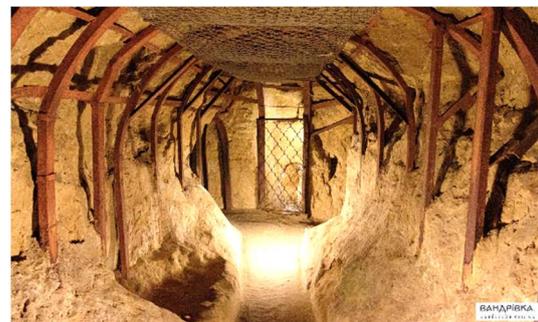
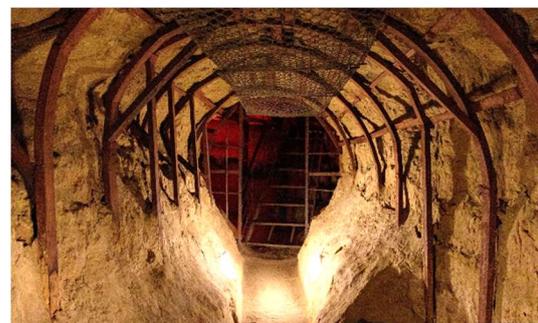
Figure 2 – Metal fasteners of Saint Anthony Caves:

- a – Photo from the archive of Viktor Koshmal <https://cutt.ly/LXahJ60>;
- b, c – <https://cutt.ly/9Nm24bk>

In 1890, one of the galleries was strengthened with metal arcs, in 1950-1960 repair and conservation works were carried out with the help of bricks, in 1998-1990 an arched fastener made of metal was used, in 1992 the entrance opening was strengthened by metal-reinforced-concrete structures, in 1993 metal-brick fasteners were installed at emergency sites (fig. 2).

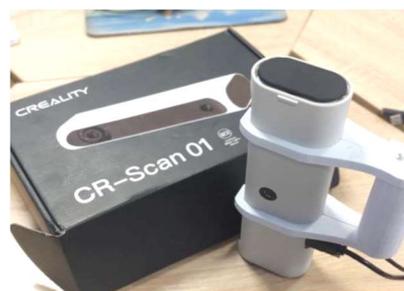
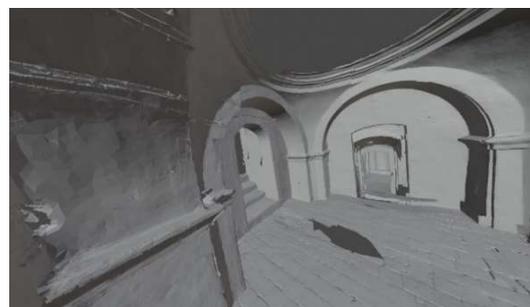
Figure 3 – Scan of Saint Anthony Caves in Chernihiv:

- a – 3D- scanner CR-Scan 01;
- b – fragment of the scanned corridor;
- c – 3D-model of the underground church of Antony Pecherskyi

As for the methods of the survey of underground complexes, in addition to using georadar to detect voids, currently widely used methods of scanning and creating 3D images to analyze how underground premises are located in space. Scientists of NU "Chernihiv Polytechnic" together with the National Architectural and Historical Reserve of "Ancient Chernihiv" began work on creating a 3D model of Saint Anthony Caves in Chernihiv (Fig. 3).

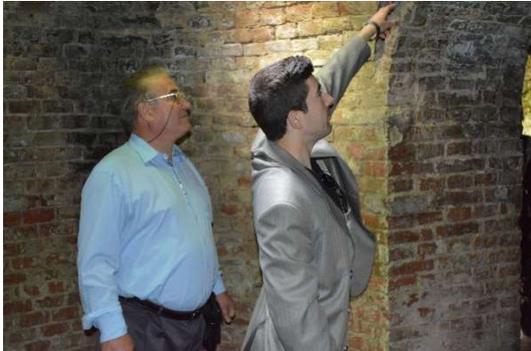
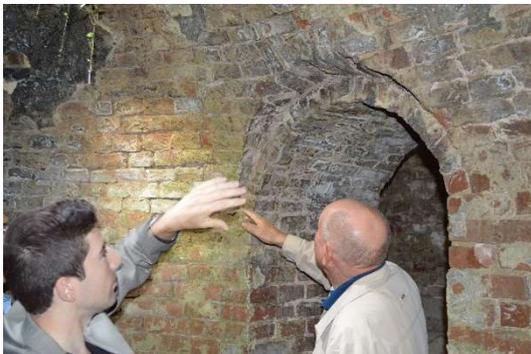
Figure 4 – Visual inspection of the grotto in the village Sedniv:

Therefore, in addition to methods for determining and locating underground facilities, it is necessary to assess the technical condition and level of reliability of such structures (Fig. 4).

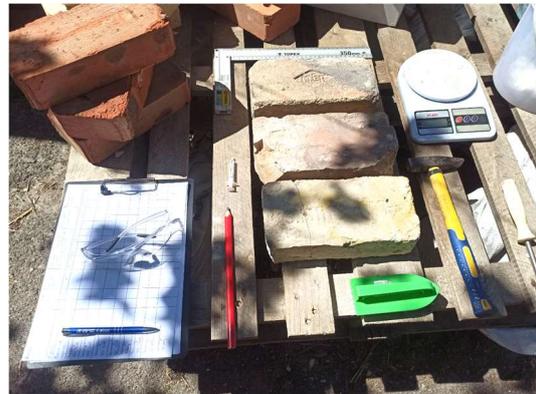
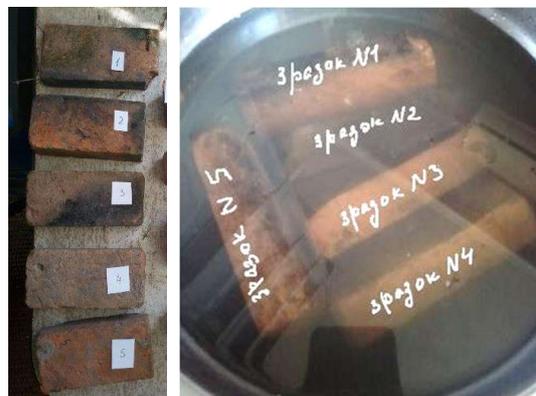
Figure 5 - Investigation of bricks on water absorption

The studies were conducted on samples of bricks selected from the brickwork of the beginning of the XX century and from a brick, which is used at present in masonry (Fig. 5).

The results of the water absorption of the products are presented in Table 1.

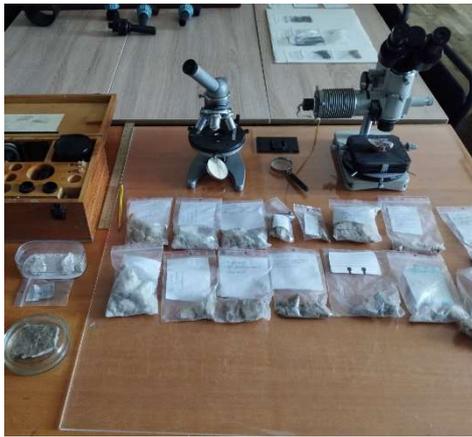
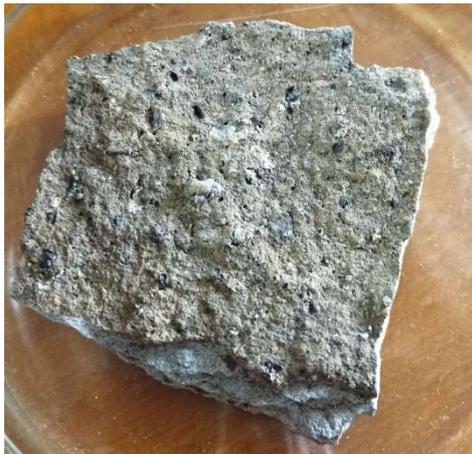
Figure 6 - Research of building solutions:
a – microscope MBS-10, MMU-3 and samples of solutions of the XXI-XX centuries;
b – a sample of the solution of the house of the manor Yatskiv, village Nove, Chernihiv region. (1892);
c – photo of the solution under the microscope (increase of 100 times)

According to the material, it is mainly - brick, stone, wood, concrete, and reinforced concrete. The solutions used clay and lime, sometimes with cemyank impurities (burnt and the ground mixture of ceramic crumbs and flour) (Fig. 6).
