Strengthening Technology for Damaged Floor Slabs through Compression Zone Enlargement and External Reinforcement

Abstract. The article presents a technology for strengthening reinforced concrete floor slabs by enlarging the compressed zone and using external reinforcement. A 50 mm-thick monolithic overlay is installed on top of the slab, while steel channels are anchored below using chemical fasteners. The slab is pre-leveled with jacks; after hardening, the beams are removed. Full-scale hydrostatic tests confirmed the restored load-bearing capacity and minimal deflections (~2 mm). The method eliminates the need for dismantling, accelerates reconstruction, reduces costs by up to 58%, and preserves interior geometry - making it highly suitable for restoring war-damaged residential buildings.

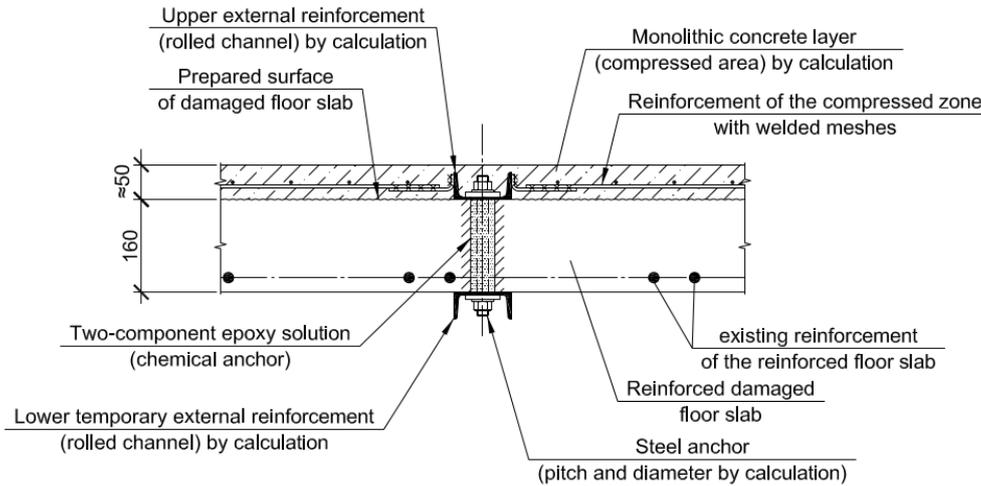
Structural solution. The strengthened reinforced concrete slab acts compositely with a new monolithic concrete layer on top and steel elements installed at the bottom. The compression zone is formed by the concrete overlay - a supplemental slab approximately 50 mm thick, made of heavy concrete (aggregate fraction 10–20 mm), placed on the top surface of the existing slab. In the tension zone along the underside of the slab, steel channels (No. 10U according to DSTU 3436-96) are installed as external reinforcement. The steel beams are positioned parallel to the slab span with a spacing of about 0.9 m (i.e., 3–4 channels per 3 m-wide slab), coordinated with the arrangement of the slab's internal reinforcement.

Chemical anchors connect all elements of the system, ensuring composite action between the old and new concrete and the steel beams. Specifically, the anchors transfer shear stresses along the contact

Anchors are placed at approximately 500 mm intervals along the beams. The anchorage depth is calculated to ensure that the anchors penetrate into the existing slab and partially extend into the overlay zone, acting as shear studs. The structural scheme of the strengthening system is shown in Fig. 1.

Figure 1 – Scheme of floor slab strengthening by enlarging the compression zone (steel beams underneath, anchors, and concrete overlay on top)

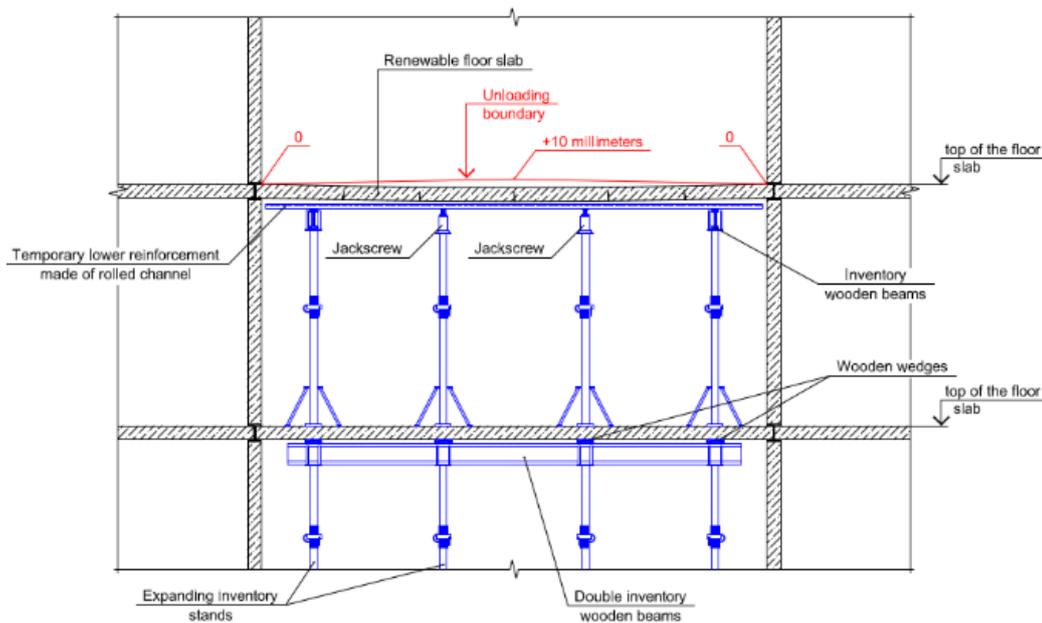
Slab unloading and leveling. An important stage is the temporary unloading of the slab and correction of its deflection. Field observations show that damaged slabs often exhibit deflections exceeding the allowable limit ($L/200$). In our case, for a 6-meter span, the permissible deflection is approximately 30 mm, and this value had been exceeded (the slab sagged beyond the norm). Therefore, before strengthening, the slab is lifted using jacks and adjustable props (Fig. 2). Typically, telescopic construction props and horizontal girders are used.

Figure 2 – Scheme of slab unloading and leveling (lifting the slab by 10 mm using jacks).

The props are placed beneath the slab, and the central zone is carefully lifted by about 10 mm. This slightly “over-bends” the slab upwards so that after the supports are removed and the new concrete gains strength, the slab becomes as level as possible. After lifting, control level measurements are taken. If necessary, the slab’s position is fixed—some jacks are left under tension, or temporary supports (wooden posts, steel tubes) are installed to maintain the corrected geometry.

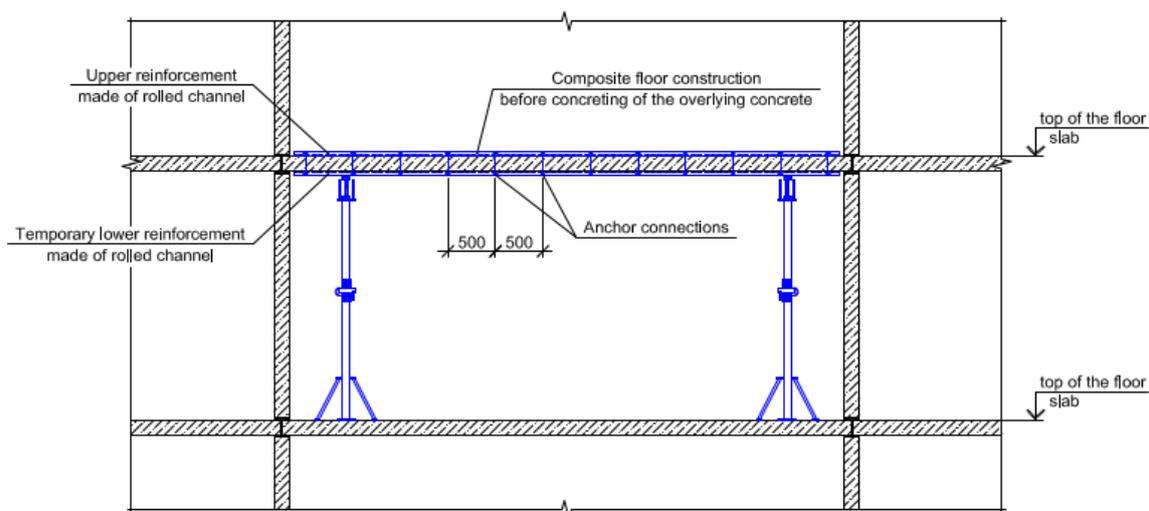
Installation of external reinforcement and anchors. The next step is the installation of steel channels along the underside of the slab (Fig. 3). If the slab is supported by props, the channels can be pressed directly against its bottom surface (between the props). The selected profiles - No. 10U, with a length matching the full span of the slab (6 m) - are fixed to the slab using chemical anchors. To do this, holes with a diameter corresponding to the anchors (e.g., 22 mm for an M20 bolt) are drilled through the slab so that each hole also passes through the web of the channel. Bolts are inserted from below through holes in the channel flange and into the drilled cavities; the cavities are then filled with epoxy compound, and once the resin hardens, nuts are tightened to press the steel beams firmly against the slab.

As a result, composite temporary girders are formed - i.e., beams consisting of steel channels and part of the existing slab connected by anchors. These composite members carry

part of the load and hold the slab in the lifted position. Subsequently, they ensure composite action during concreting of the upper surface and partially replace the temporary props.

Figure 3 – Scheme of composite elements formed by the floor slab and external reinforcement using rolled steel channels

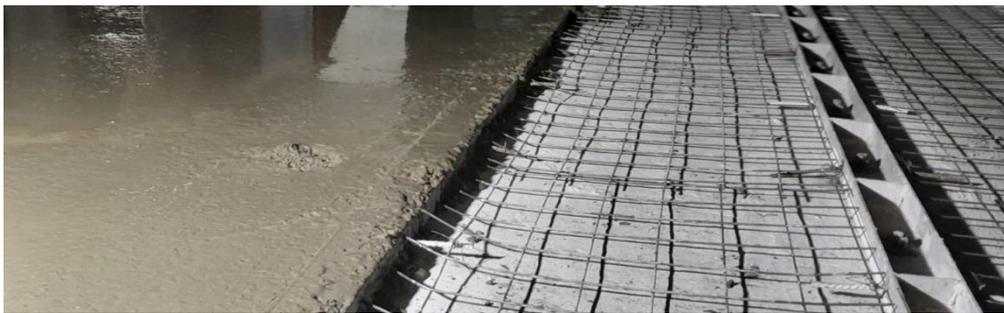
Concrete casting of the overlay. After preparing the reinforcement, the new concrete layer is placed (Fig. 4). Formwork (wooden or plastic boards) approximately 50 mm high is installed around the perimeter of the slab to prevent the concrete from spreading. A high-quality concrete mix is recommended, not lower than class C20/25, with fine aggregate to ensure good adhesion and proper filling of the thin layer. Before casting, the entire surface of the existing concrete is moistened with water, or preferably coated with a bonding layer (a cement-sand slurry or a special adhesive “contact layer”). Concreting is performed uniformly across the slab to the design thickness (e.g., 50 mm). The mix is compacted with a needle vibrator (if the layer thickness is sufficient) or by rodding, ensuring that no voids remain - especially around anchors and dowels. The surface of the overlay is levelled with a straightedge.

Figure 4 – Concrete casting process

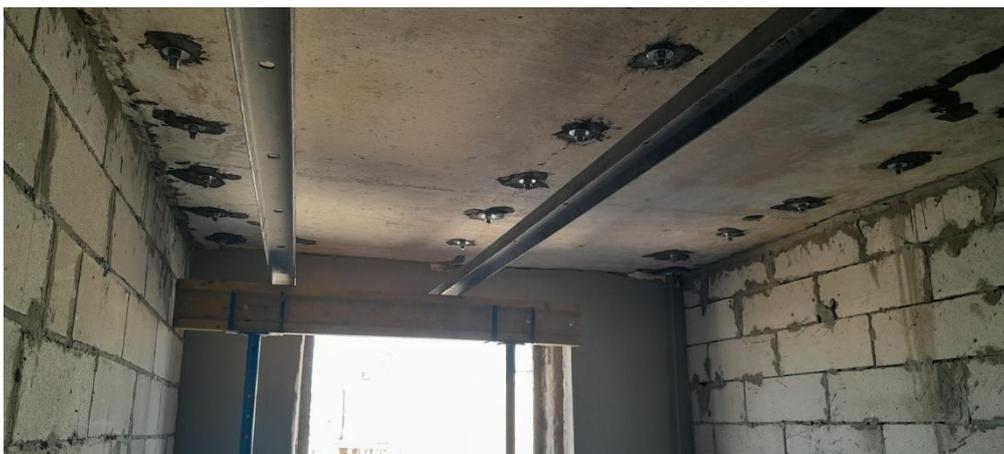
Removal of steel beams. After the concrete overlay has reached its design strength (at least 28 days, or based on the results of control cube tests), the lower steel channels are no longer required as permanent strengthening elements (Fig. 5). Calculations have shown that due to the increased effective depth of the slab and its composite action with the new layer, the existing reinforcement is capable of resisting all design bending moments without the assistance of the channels. Therefore, the channels can be dismantled and reused at other locations.

To remove them, the nuts on the anchor bolts are unscrewed and the beams are detached from the slab (a light tap may be required if the beams have adhered to the concrete). The anchor rods remain embedded within the slab

and continue to connect the overlay to the original concrete. If any rods protrude below the slab, the excess length can be cut flush with the surface.

Figure 5 – Removal of steel beams

The test results demonstrated the high effectiveness of the system. The maximum deflection of the slabs under hydrostatic loading before beam removal was approximately 1.95–2.1 mm, and after removal—about 2.31–2.4 mm. Thus, the difference was only ~15–20%. These deflections are extremely small compared to the allowable value of 20 mm for the given span. Therefore, even without the steel strengthening underneath, the strengthened slabs fully withstand the design load with a significant stiffness reserve. The relative stiffness after strengthening increased by roughly a factor of 10, since before the repair the deflections far exceeded the limit (over 30 mm), and the slabs were considered in an emergency condition.
