Peculiarities of residential buildings deformation with connected block-sections collision as a result of uneven settlement on collapsible soils

^{1,2} Zaporizhzhia branch of State Enterprise «State Research Institute of Building Constructions»

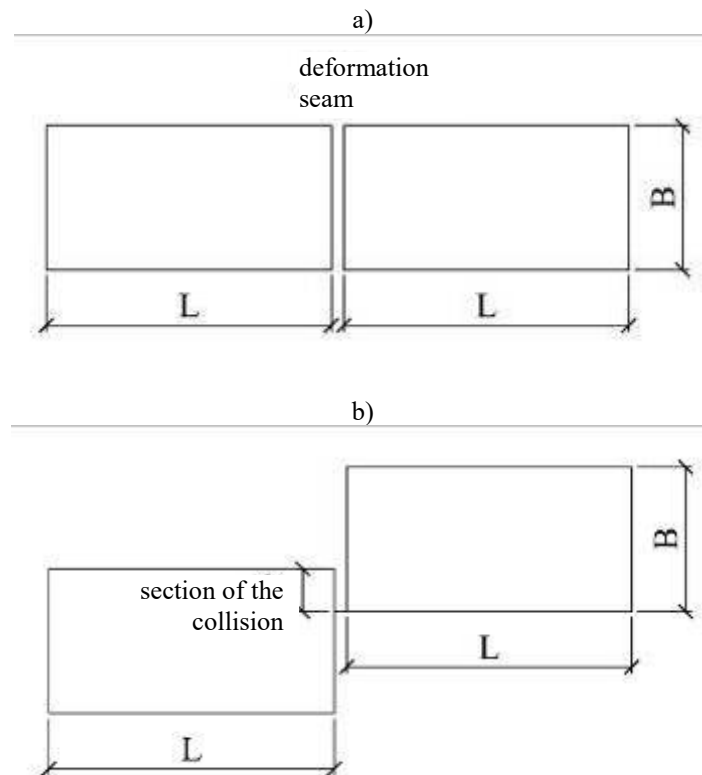
Figure 1 – Blocking circuit in terms of residential buildings block-sections:

- a – without displacement in transverse direction;
- b – with mutual displacement in transverse direction

From Figure 1 it can be seen that variants provide blocking of block-sections without mutual displacement in the transverse direction of block-sections and so displacements. Buildings operation experience shows that when uneven subsiding and tilting in block-sections collisions of the upper parts are formed. An important factor is the block section collision area magnitude. Figure 1 shows the blocking options for block-sections that are used on mass building of Ukrainian cities. The practice of designing residential buildings shows that the areas of block-
